Structural Assessment Report
For
Boyd Family Trust Residence
1250 Cliff Drive

January 13, 2015

**Subject: Structural Assessment
Boyd Family Trust Residence
1250 Cliff Drive
ESH 14-146**

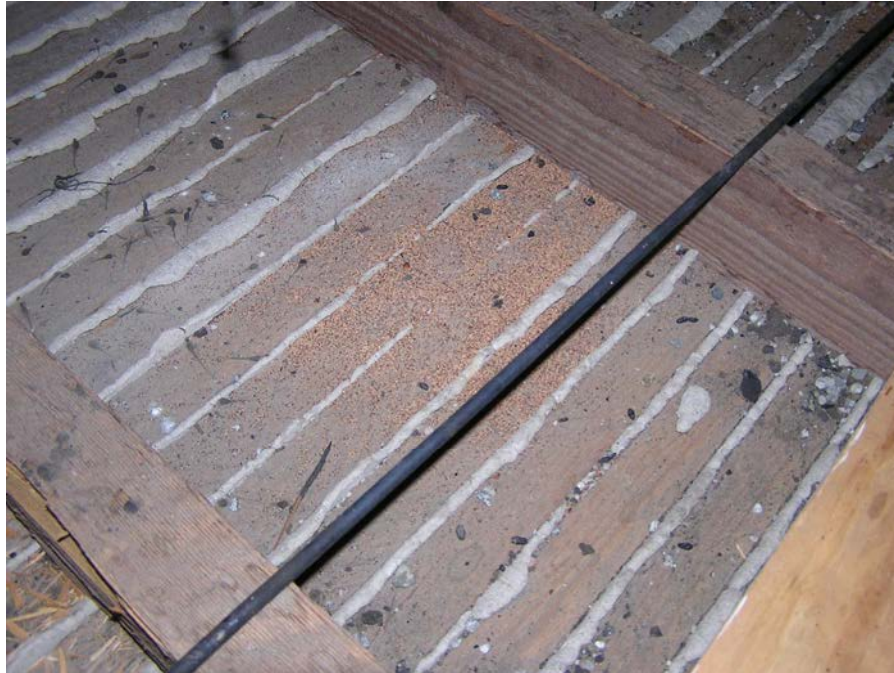
1. There were some signs of termite activity observed in the attic, although no significant structural damage was noted (Photograph #1). Since we are not termite experts, we recommend that a pest control specialist perform a thorough inspection of the residence and determine if there is an active termite infestation that needs to be treated.

Photograph #1: Signs of Termite Activity

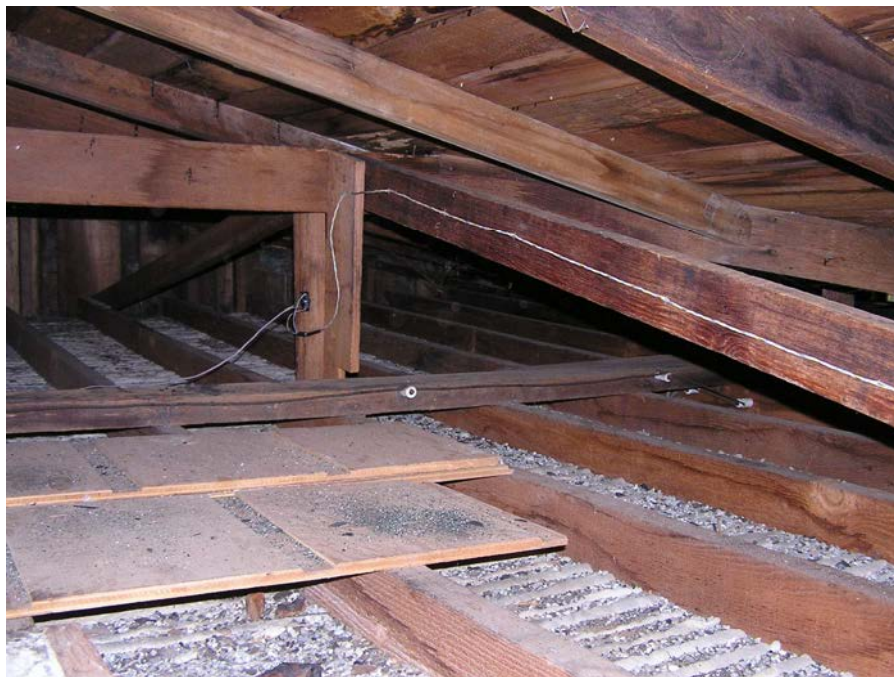
2. The ceiling over the bedroom on the second floor at the southeast corner is noticeably deflected due to the long span of the 2x4 ceiling joists and will need to be adjusted and strengthening to remove the sag (Photograph #2).

Photograph #2: Deflected Second Floor Ceiling Joists

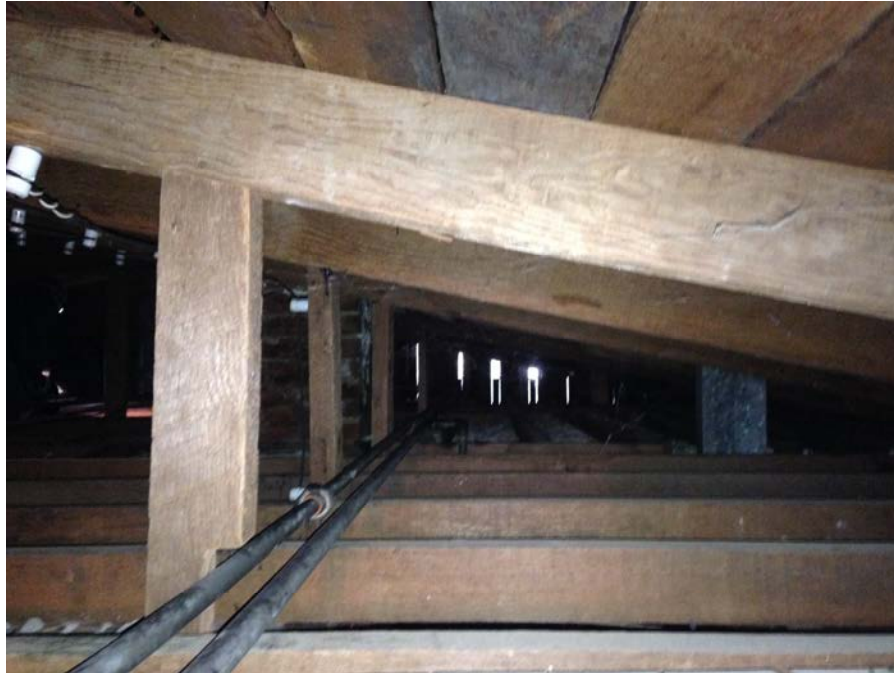
3. The typical roof joist is supported at the exterior wall, ridge line and by a 2x4 stud located roughly mid-span that bears on a wall below. There is only minimal attachment between the joist and the stud and the wall below (Photograph #3).

Photograph #3: 2x4 Stud Supporting Roof Rafter

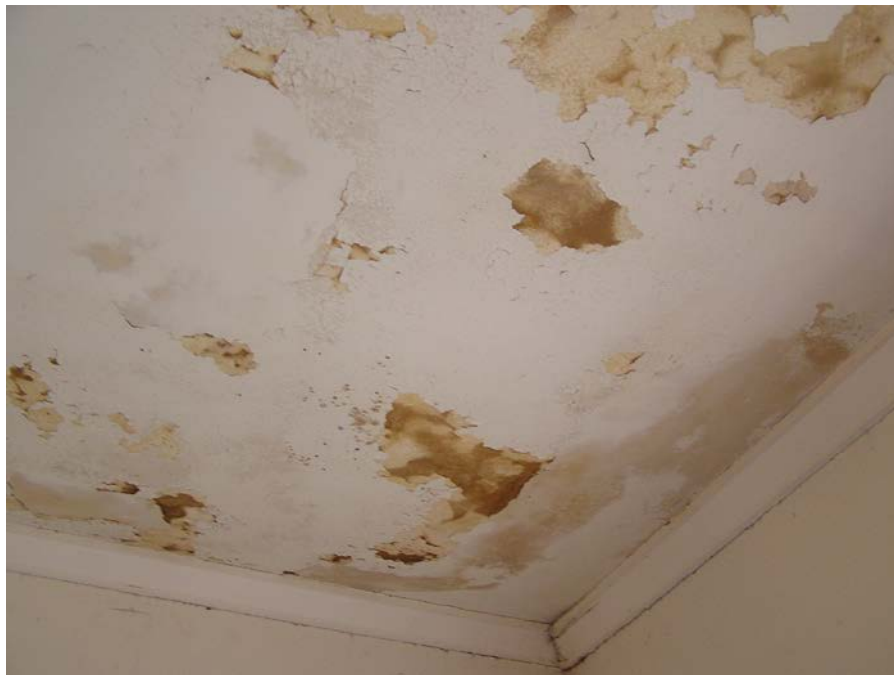
4. The first floor ceilings below the two exterior decks that occur on the second floor are significantly stained presumably due to water intrusion from above. We were unable to gain access to the exterior decks therefore the condition of the walking surface is not known. In addition, the condition of the wood framed decks could not be observed but some damage should be anticipated (Photograph #4).

Photograph #4: Stained Ceiling at First Floor Below Exterior Balcony

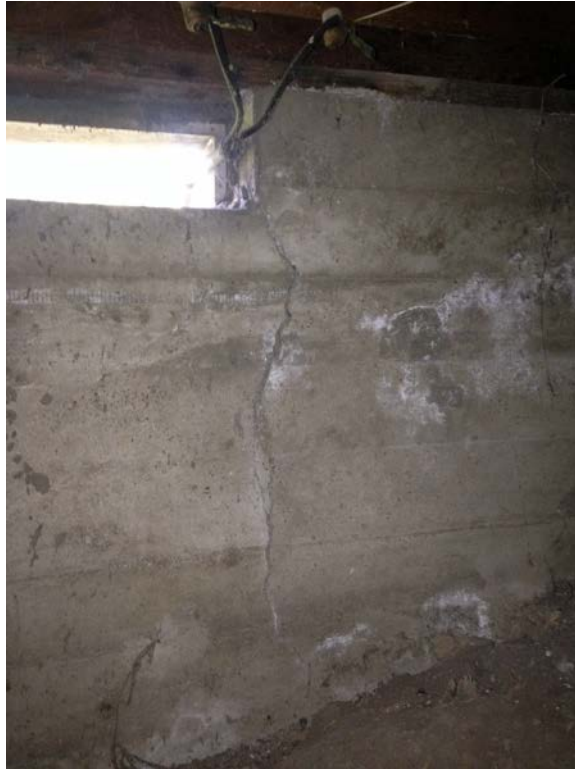
6. There was one significant crack noted in the concrete foundation wall and brick veneer at the front of the house near the southeast corner. Based on the crack patten, it appears that the southeast corner of the house may have settled over time. A floor elevation survey will be necessary to confirm if settlement has occurred (Photographs #5 & #6). Due to the age of the structure, a soils investigation may

Photograph #5: Crack In Foundation Wall On South Side

not have been conducted prior to construction. If it is determined that settlement has occurred, a Geotechnical Engineering investigation is recommended in order to determine the cause of the settlement and a plan for stabilizing this portion of the structure.

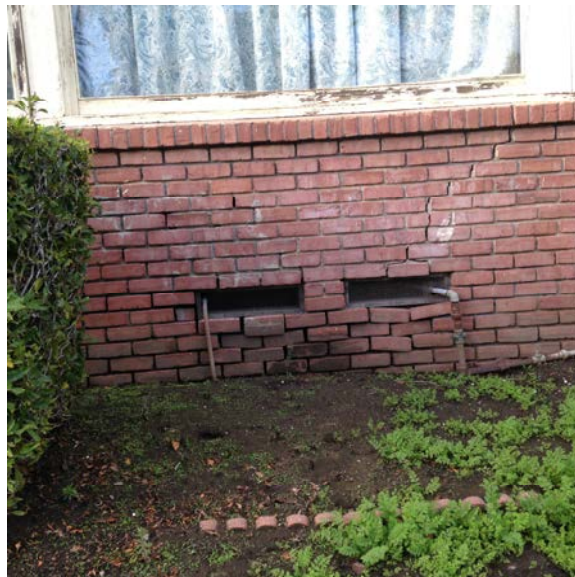
Photograph #6: Cracked Brick Veneer at Southeast Corner

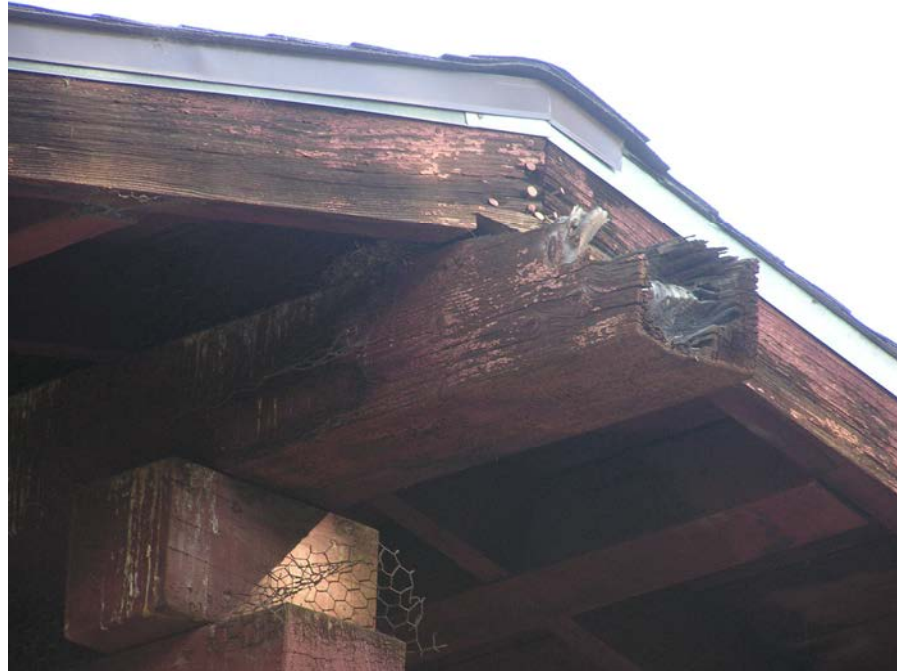
7. At the roof overhangs, many of the exposed wood members have significant damage due to dry rot and will need to be repaired and or replaced. In several areas and particularly at the 3 second floor balconies, the wood shingles appear to be stained and may be damaged due to water intrusion (Photographs #7 & #8).
8. In the areas of the crawl space that we were able to observe, there were no anchor bolts observed connecting the wood framing to the concrete foundation walls.
9. Around the perimeter of the structure there were several areas noted where the mortar in the brick veneer has deteriorated and will need to be repaired (Photograph #9).
10. At the southwest corner of the structure, a blue tarp has been installed to cover a portion of the exterior wall (Photograph #10). The conditions under the tarp are not known.

Photograph #7: Damaged Exposed Wood Framing Below Roof Overhang

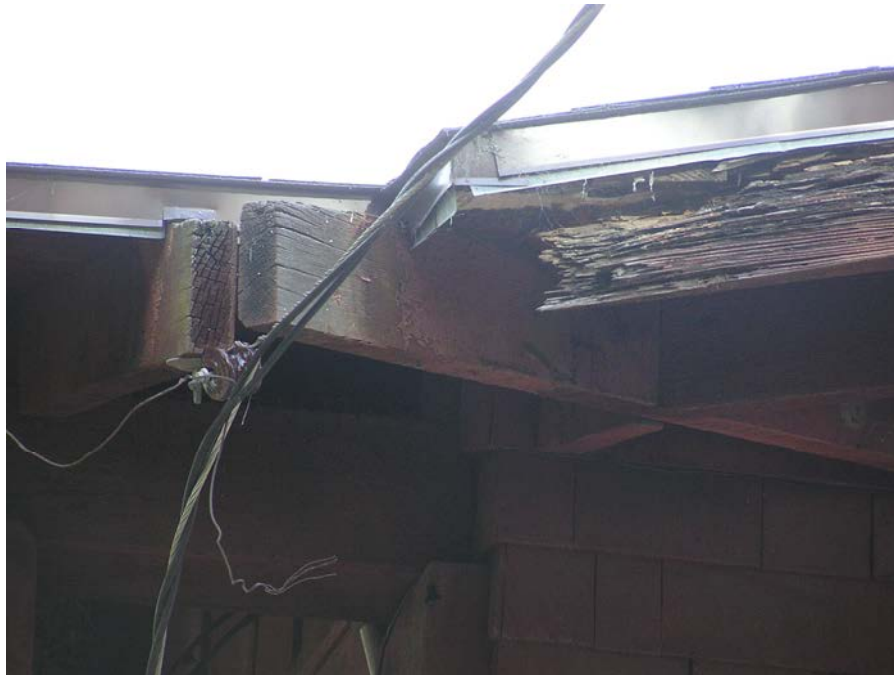
Photograph #8: Damaged Exposed Wood Framing Below Roof Overhang

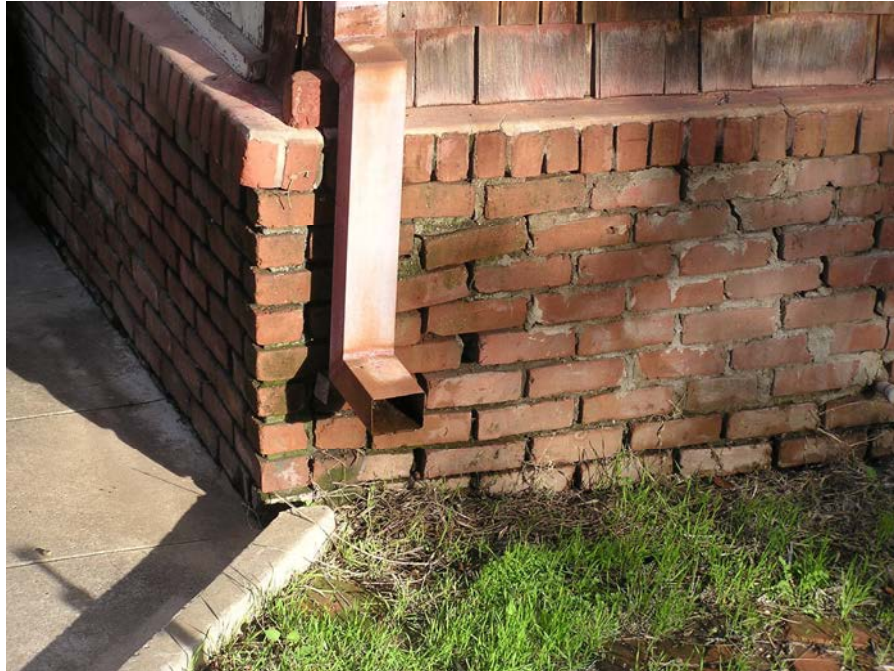
Photograph #9: Deteriorated Mortar in Brick Veneer

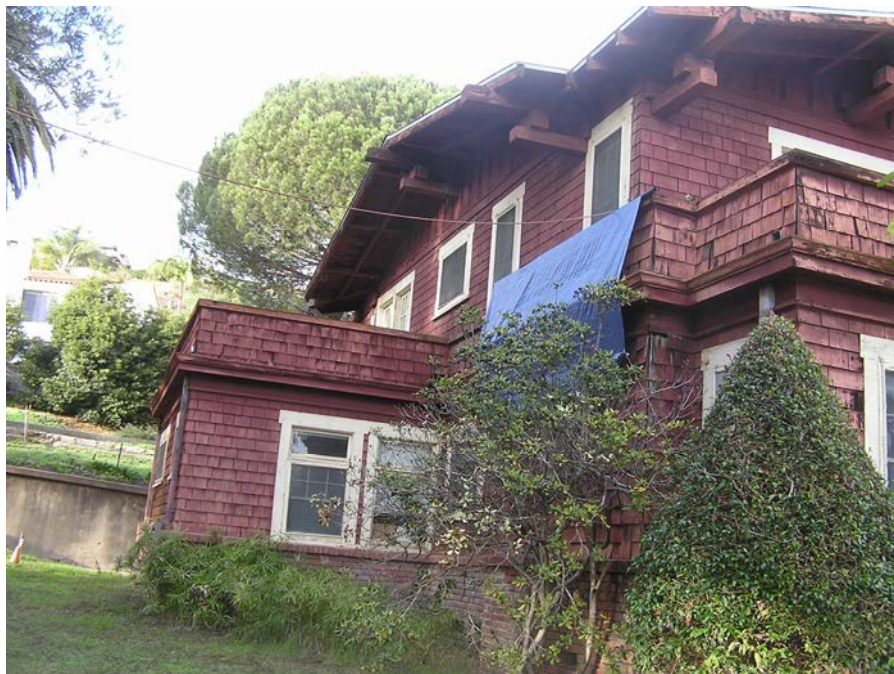
Photograph #10: Tarp on West Side
