# Confidential Inspection Report

PROPERTY LOCATED AT:  
3101 Calle Mariposa  
Santa Barbara, California

INSPECTED ON:  
Tuesday, November 29, 2016

Inspector, George Blair  
Checkpoint Inspection Service

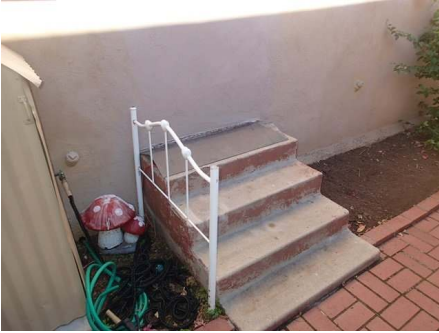
**ER 7:** - Additions or alterations may have been made to this property. Therefore, you should request documentation that should include permits and any warranties or guarantees that might be applicable, because we do not approve of, or tacitly endorse, any work that was completed without permits, and latent defects could exist.

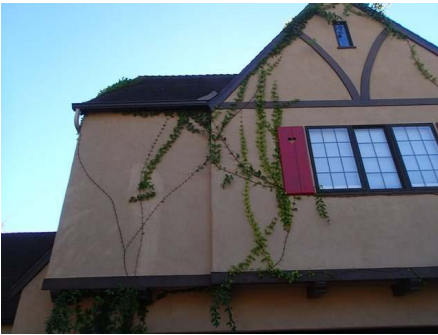
**NS 14:** - Vegetation is encroaching on the structure, and should be kept a minimum of twelve inches away for the general welfare of the walls and foundation. Moisture damage and pest access are sometimes the result of this condition.

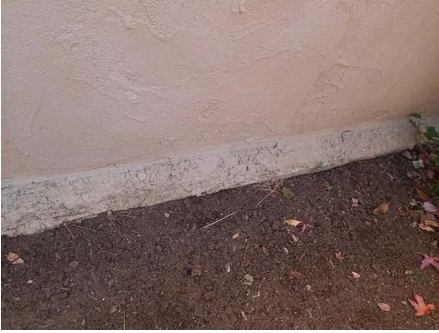
**ER 25:** - Flash walls have been added, typically to forestall moisture intrusion. You should ask the owner about any history of past moisture intrusion.

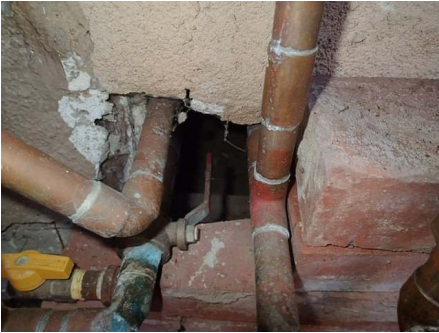
**NS 30:** - Holes gaps or openings were visible that should be serviced to prevent pests and moisture from entering the structure.

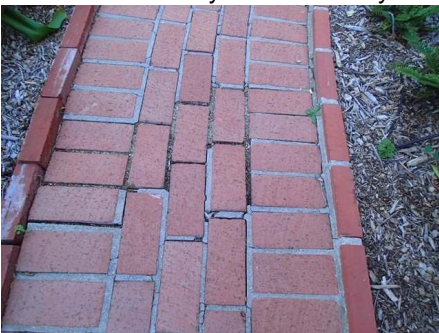
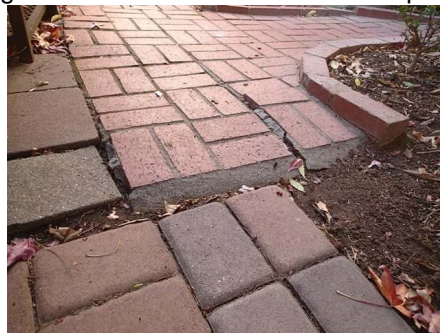
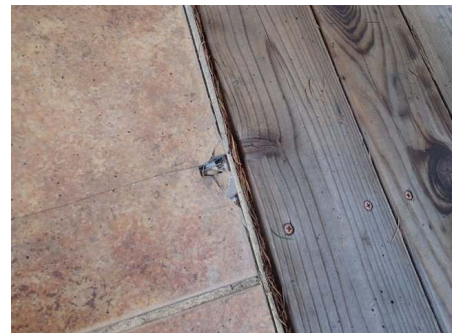
**33:** - The walkways are variously damaged and should be evaluated for repairs.

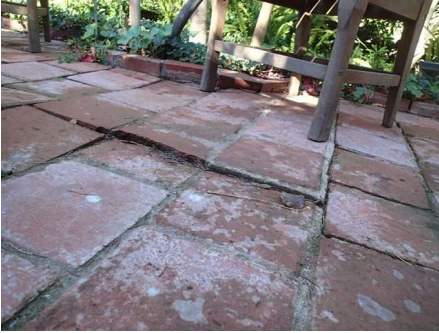
**NS** 34: - There is an offset or offsets in a walkway that could prove to be a trip-hazard.

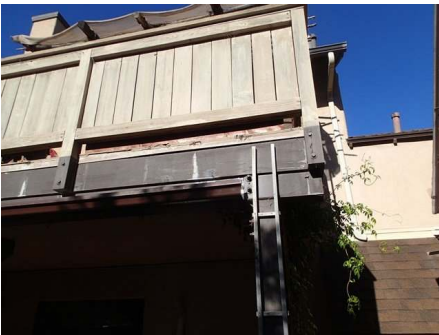
**ER** 39: - Moisture stains were visible. We recommend the further review, advice and services of a termite inspector.

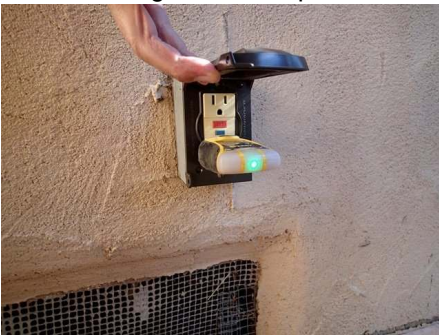
**NS** 46: - A ground-fault protected outlet in the yard does not trip on test, and should be serviced.

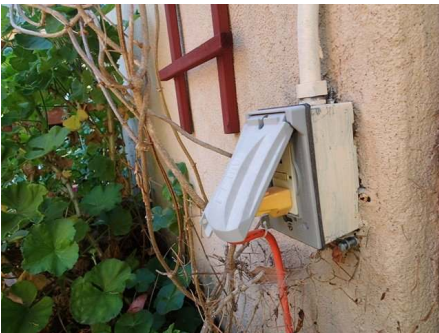
**UG** 47: - Bubble type covers are recommended for permanently installed exterior components because they are more resistant to moisture.

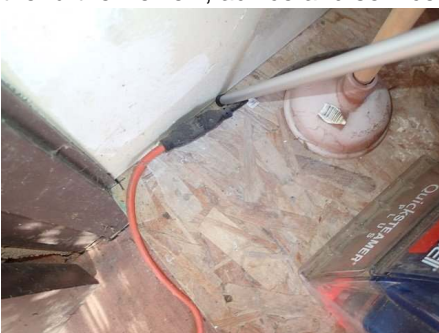
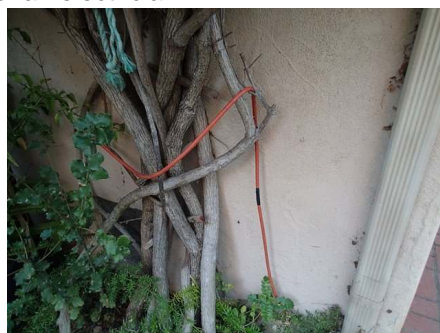
**ER UG** 48: - Extension cords were in use confirming there are not enough outlets for current uses. We recommend the further review, advice and services of an electrician.

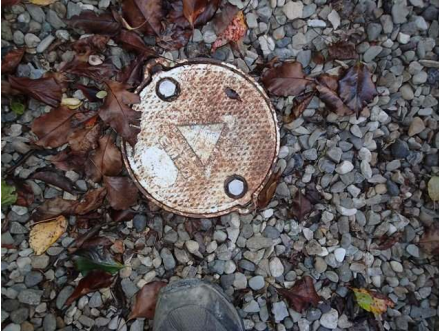
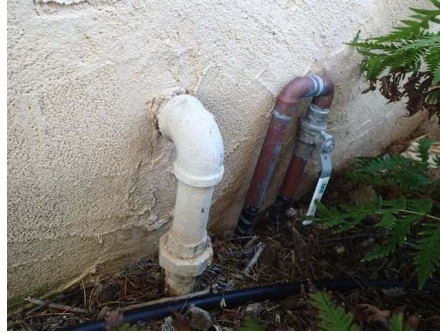
ER 51: - Unidentified pipes, valves and conduits should be identified.

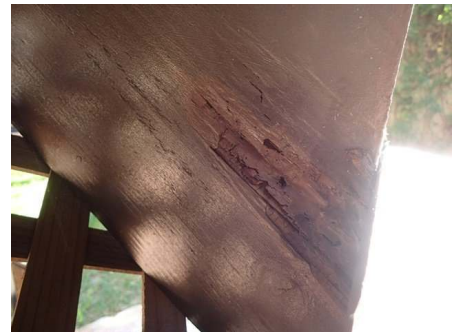
NS ER 54: - The stairs are damaged.

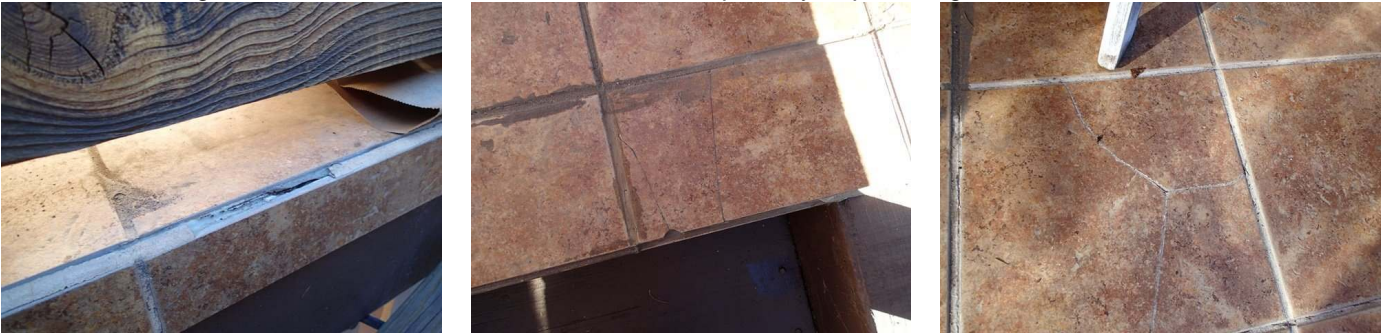
**ER** 56: - Damage was visible that should be evaluated for repairs by a qualified general contractor.

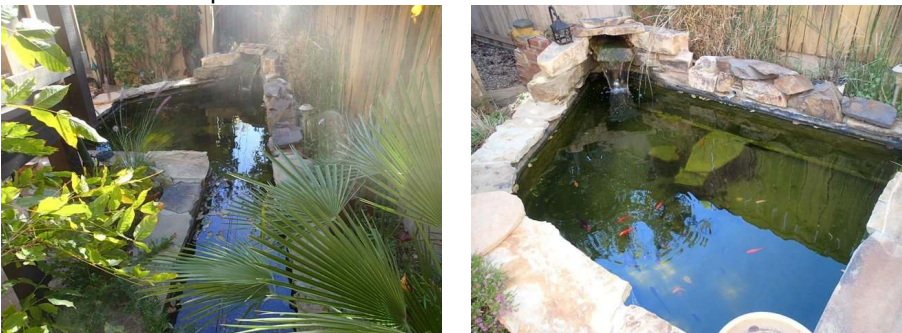
**NS** **ER** 59: - Water features were not inspected. Plumbing and electric require building department approval and we recommend a permit check on all such additions.

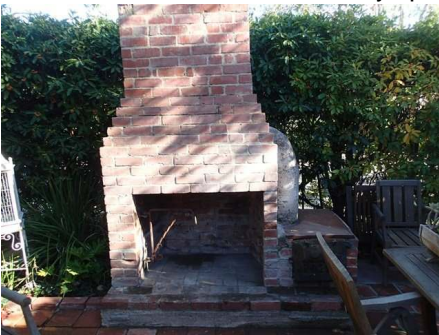
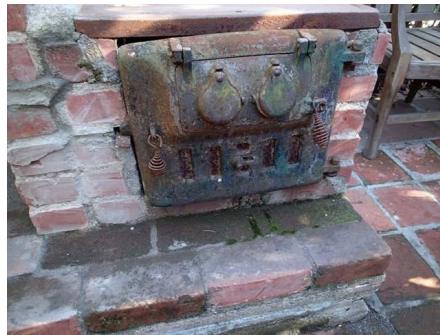
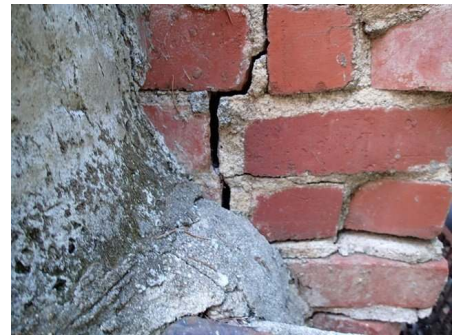
**ER 60:** - The chimney wall is cracked, and should be evaluated by a specialist. We recommend the further review, advice and services of a chimney specialist.

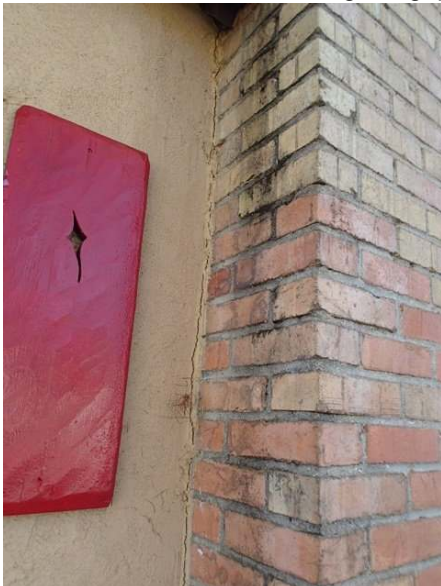
**ER 67:** - There is no flashing but gaps were visible that suggest movement. Worn and or missing caulk.

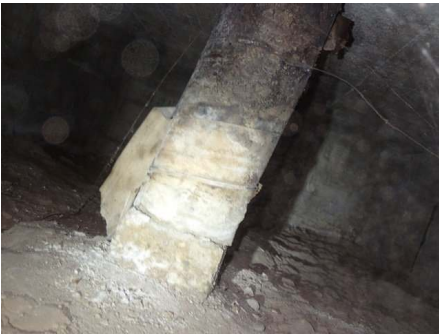
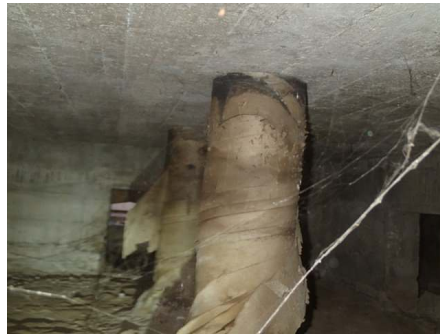
**ER 91:** - Miscellaneous construction debris or materials were noted in the crawlspace. There are unidentified black stains on the deteriorating cardboard forms in the crawlspace. The inspector does not move the occupants belongings and the areas behind obstructions were not visible.

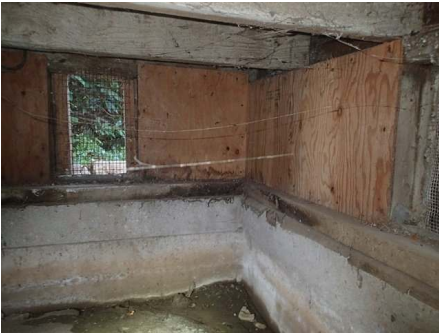
**ER 92:** - Signs of prior moisture that confirm moisture intrusion. While this condition is not uncommon, we recommend the further review, advice and services of a grading and drainage contractor.

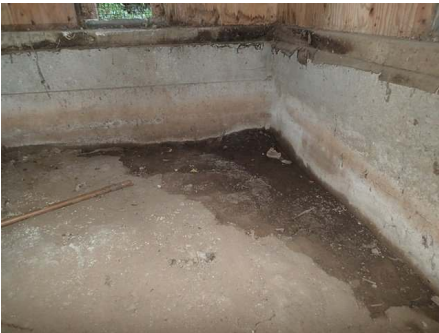
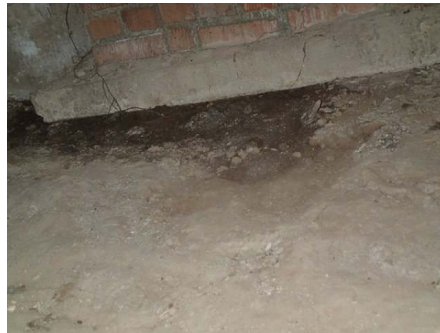
**ER 93:** - The soils were wet. In a few areas.

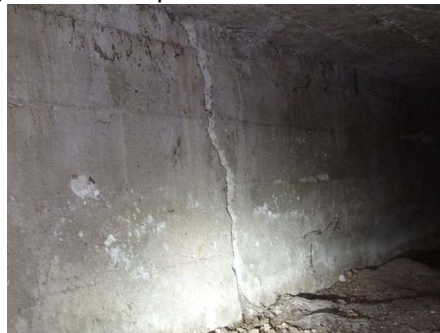
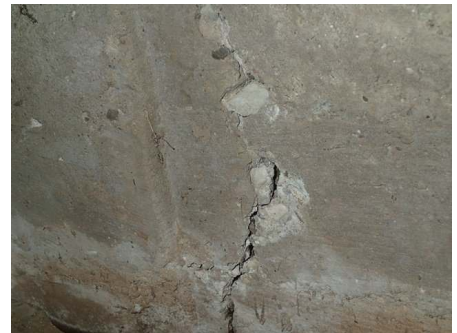
**ER 99:** - There are cracks in the foundation walls. Vertical cracks that are less than 1/4" and show no offsets or settlement are not uncommon and rarely indicate significant movement, but we are not specialists and you should consult with a foundation contractor or geotechnical specialist.

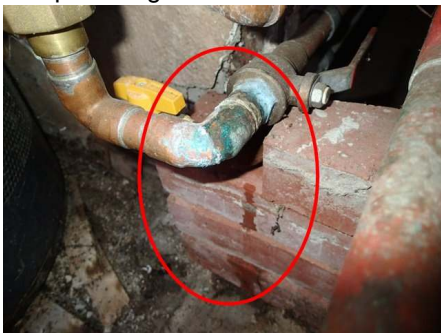
**NS** 126: - There was a leak: In the water heater enclosure. We recommend the further review, advice and services of a plumbing contractor.

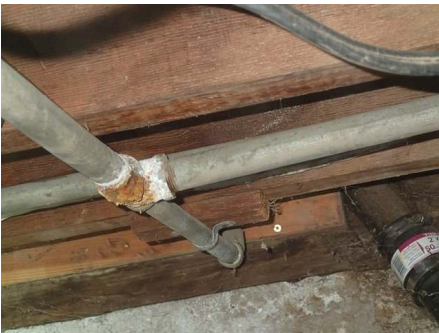
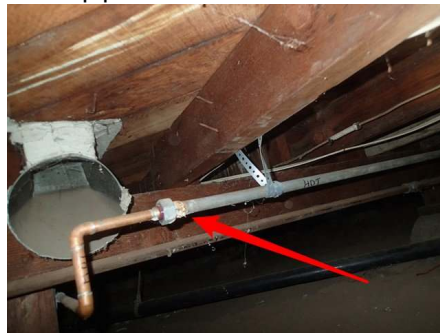
**ER 132:** - There was visible corrosion on the pipes.

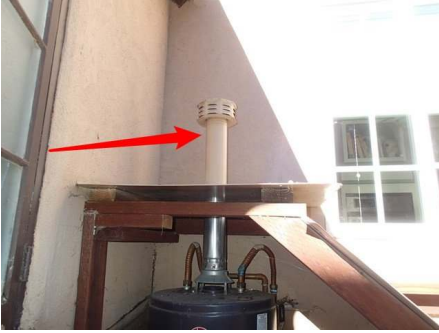
**ER 146:** - The vent pipe does not extend beyond the roof line and is required to do so. We recommend the further review, advice and services of a plumbing contractor.

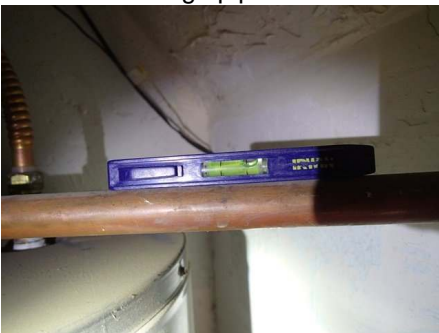
**NS 149:** - The discharge pipe from the pressure relief valve has been incorrectly plumbed uphill. This is not correct and the discharge pipe should be correctly plumbed.

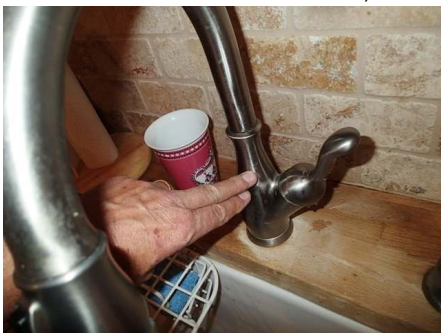
**NS 179:** - The faucet is loose, and should be secured.

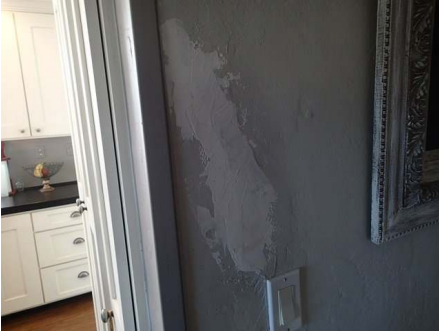
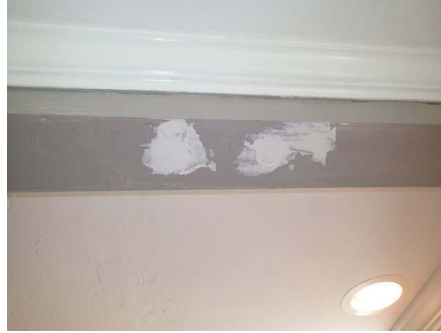
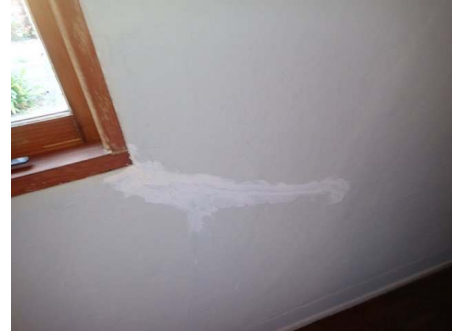
**ER** 213: - Patches were visible that should be evaluated. Walls and or ceilings.

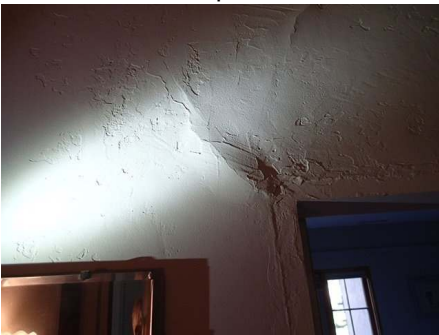
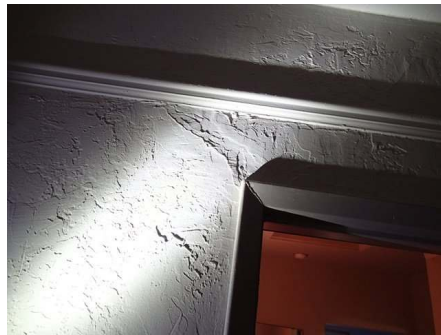
**ER** 214: - Some patched areas have re cracked.

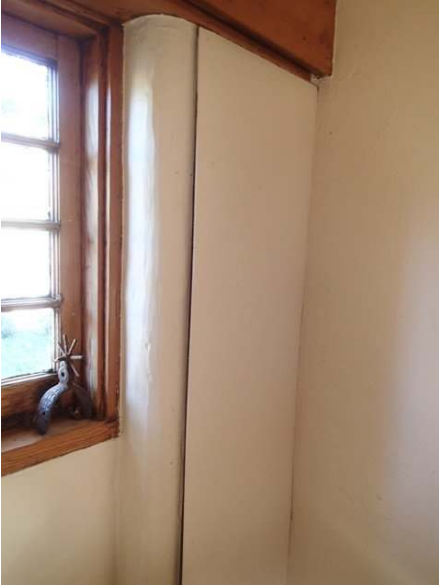
**ER** 215: - Unidentified: Added panels in the living room.

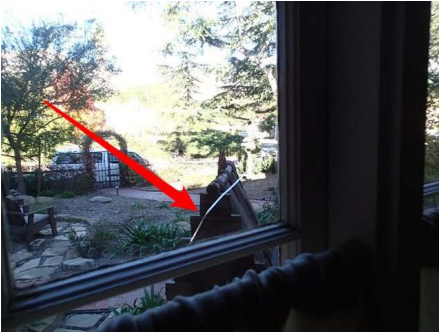
**NS** **ER** **216:** - A window pane is cracked which you should have repaired. We recommend the further review, advice and services of a window installer/repair person.

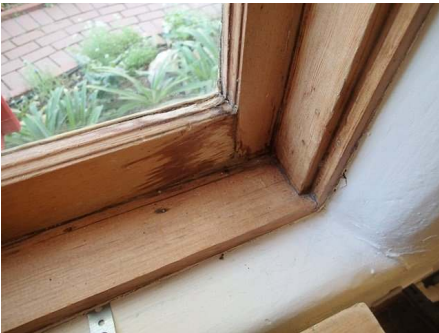
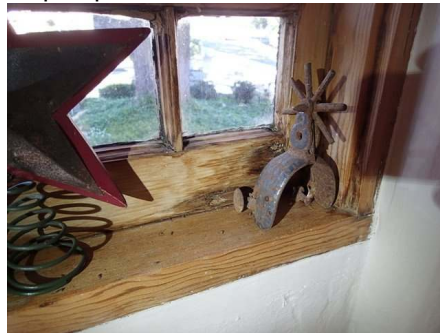
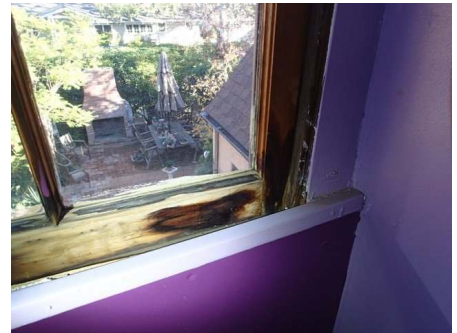
**ER** **217:** - Moisture stains and or damage were noted at some window sills. We recommend the further review, advice and services of a window installer/repair person.

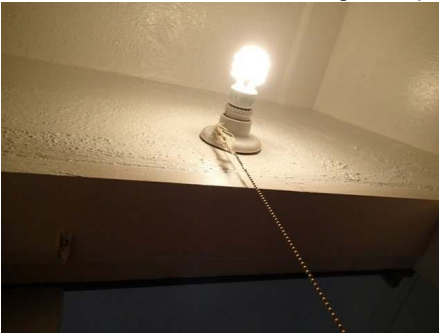
**NS UG** 222: - The closet light employs a metal pull chain that should be replaced with a safer cord type.

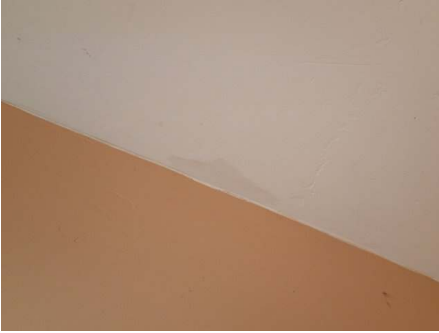
**233:** - Unidentified: Discoloration, stains. Mold testing is outside the scope of a home inspection.

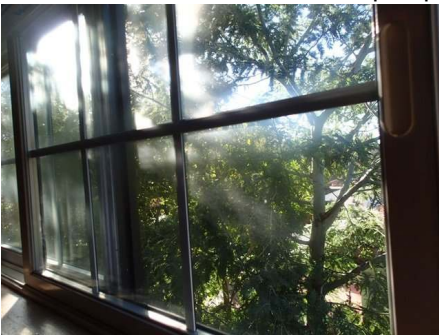
**234:** - Some windows and or doors have a broken hermetic seal, and should be replaced. This is evident from fogging, or condensation forming between the panes of glass, that confirm that the seal has failed. This condition is not always discernable due to temperature and lighting variations. We recommend the further review, advice and services of a window installer/repair person.

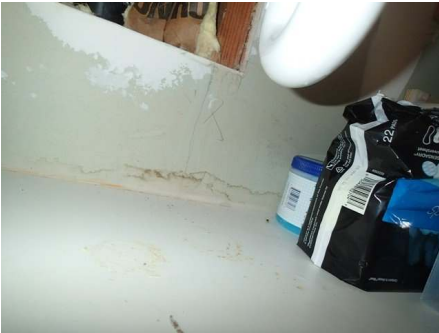
**ER** **250:** - Moisture stains: Confirm prior leaks.

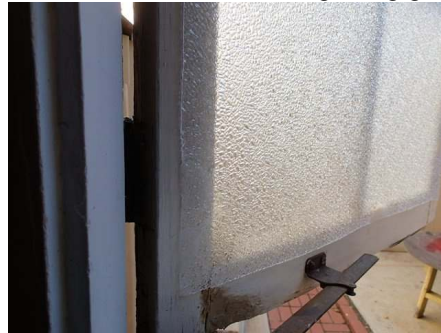
**ER** 259: - There are moisture stains around the window. Plastic glazing glued to the window.

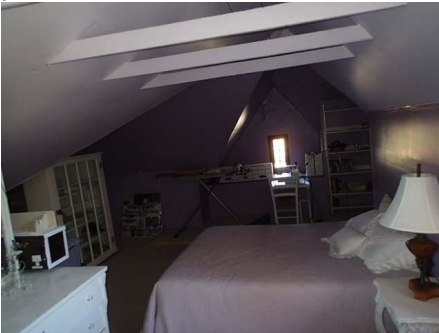
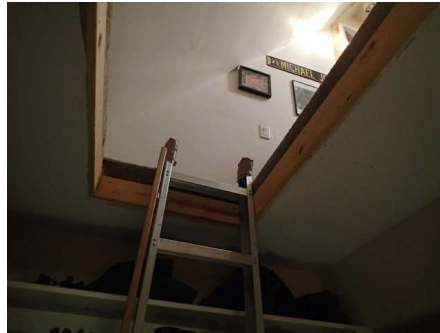
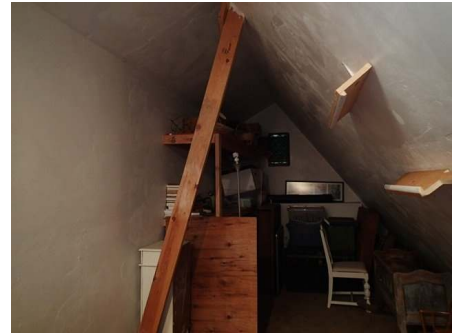
**ER** 285: - A room appears to have been added at the attic. Check permits on this apparent addition, we do not approve of alterations that have not been approved and inspected by the authority having jurisdiction over building permits.

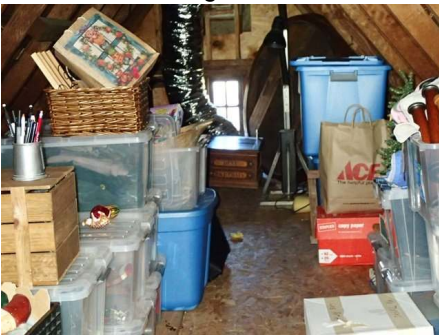
**ER 290:** - Storage within the attic limits access and evaluation.

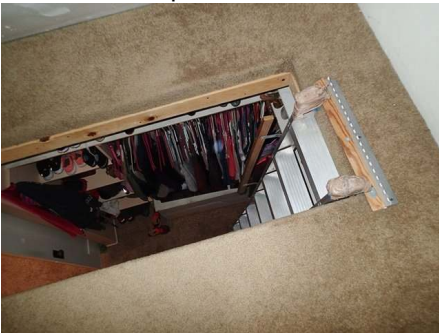
**UG 291:** - Trip hazard at the ladder. No guardrails.

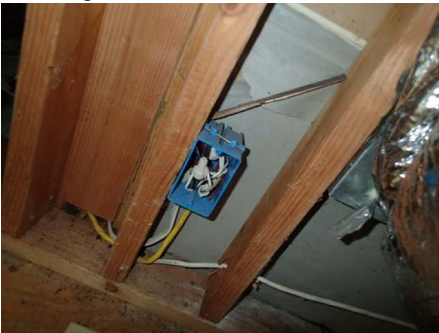
**NS** **ER** 298: - There are open electrical junction boxes, which should be sealed to contain any arcing or sparking that might occur.

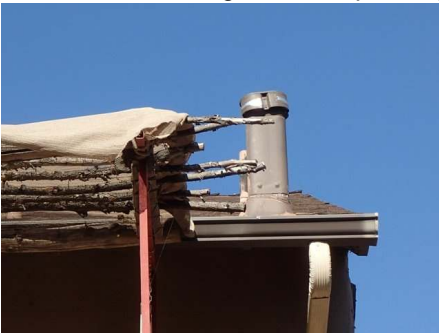
**NS** **ER** 323: - A gas vent cap is displaced on the roof. This condition should be evaluated.

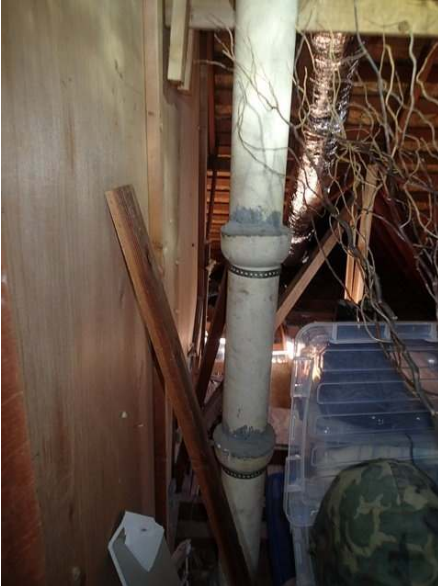
**ER 330:** - The vent pipe includes a Transite pipe, which is comprised of a solid, cement-like, material that is known to contain asbestos fibers. Admittedly, these fibers could not easily escape from within the material, but you should evaluate further.

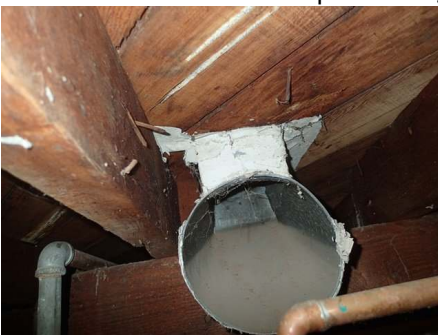
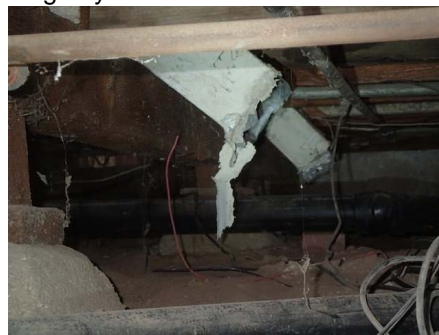
**NS ER 331:** - Asbestos like materials were noted at the basement / crawlspace . Identifying asbestos is outside the scope of this inspection. We recommend service and evaluation by a qualified specialist. Any future work should be evaluated with this in mind prior to beginning any work.
