Berkshire Hathaway
3101 Calle Mariposa
Santa Barbara, CA 93105
c/o Ken Switzer

SAFEGUARD ROOFING

Roof Inspection Report

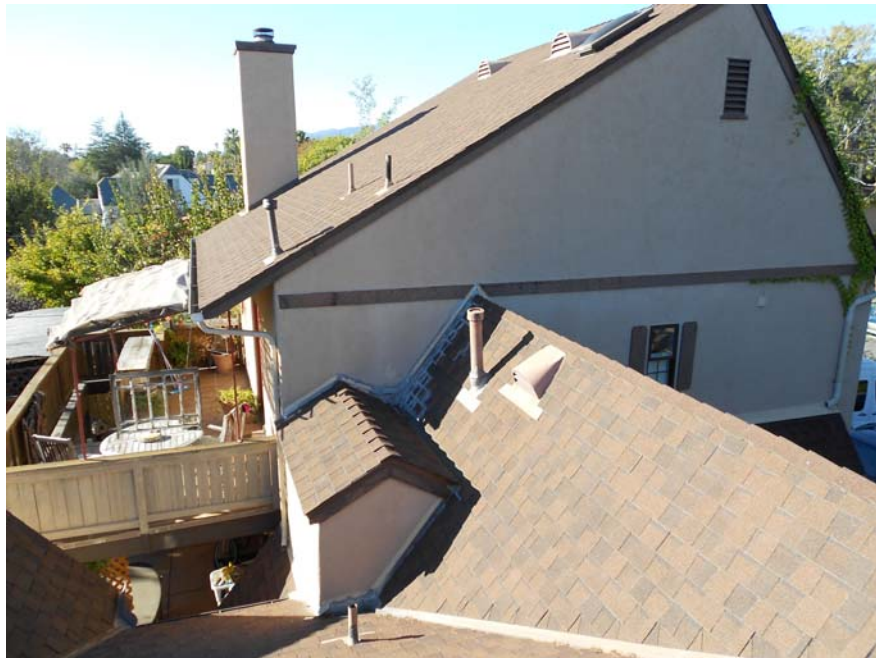
The existing roof consists of dimensional composition shingles installed over a 30# felt underlayment.

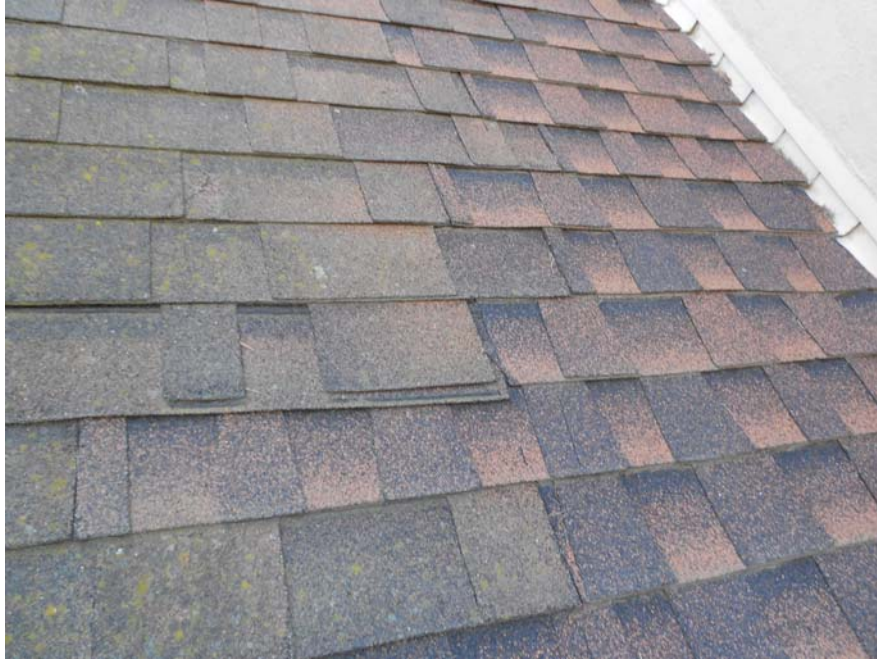
- The front section of the house is a combination of the older shingles with patches of newer shingles interwoven in several areas.

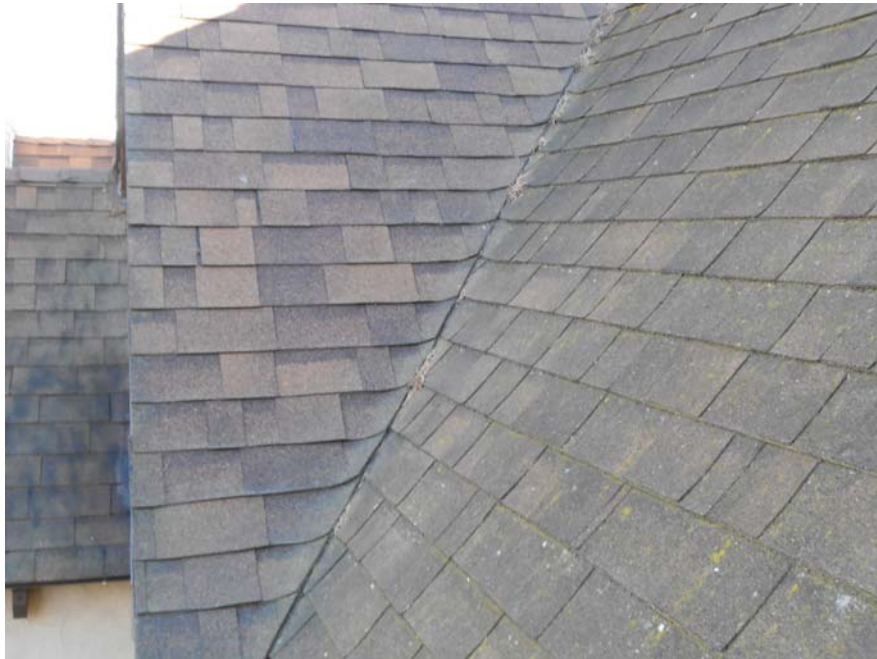
- There are newer shingles over the front entryway and older shingles on the main part of the roof.

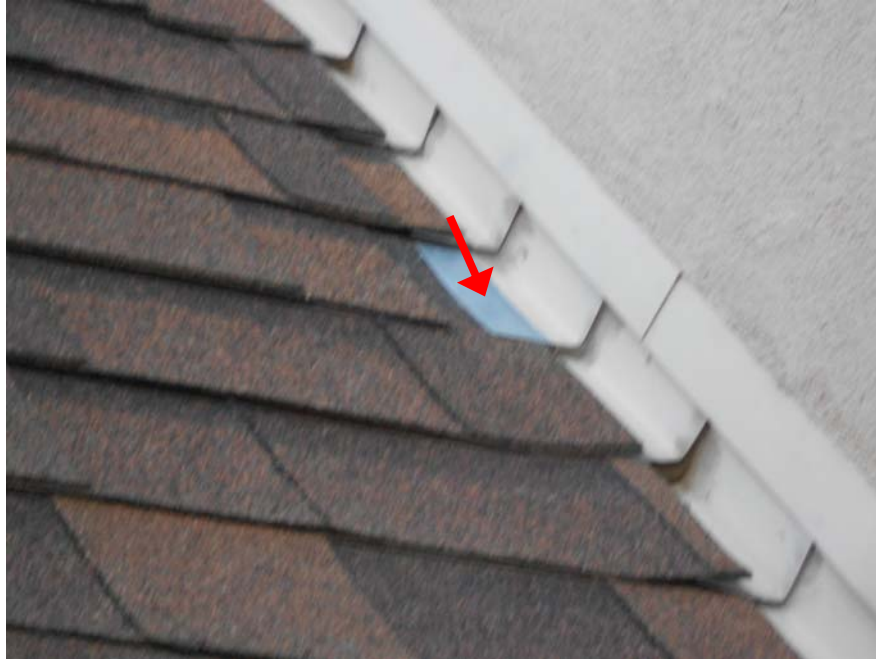
- This photo shows the roof to wall area on the front side where one shingle is missing.

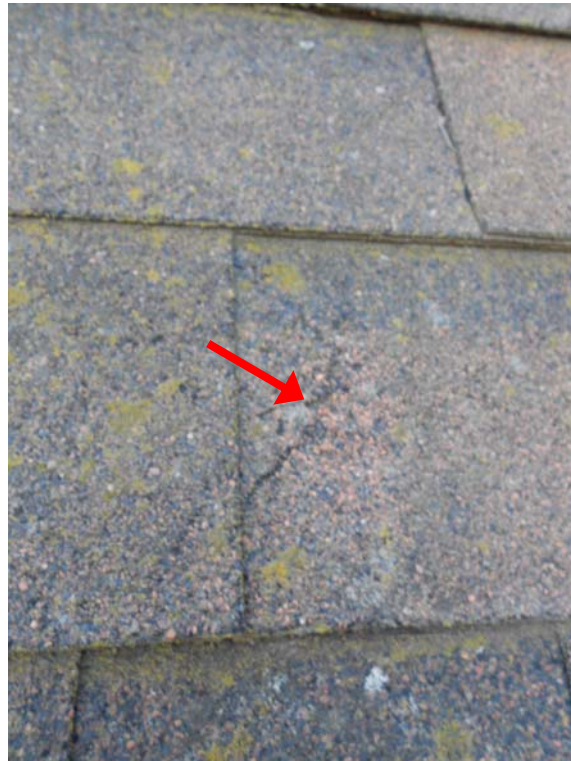
- This photo shows a shingle adjacent to the tie-in where one of the older shingles is cracked.

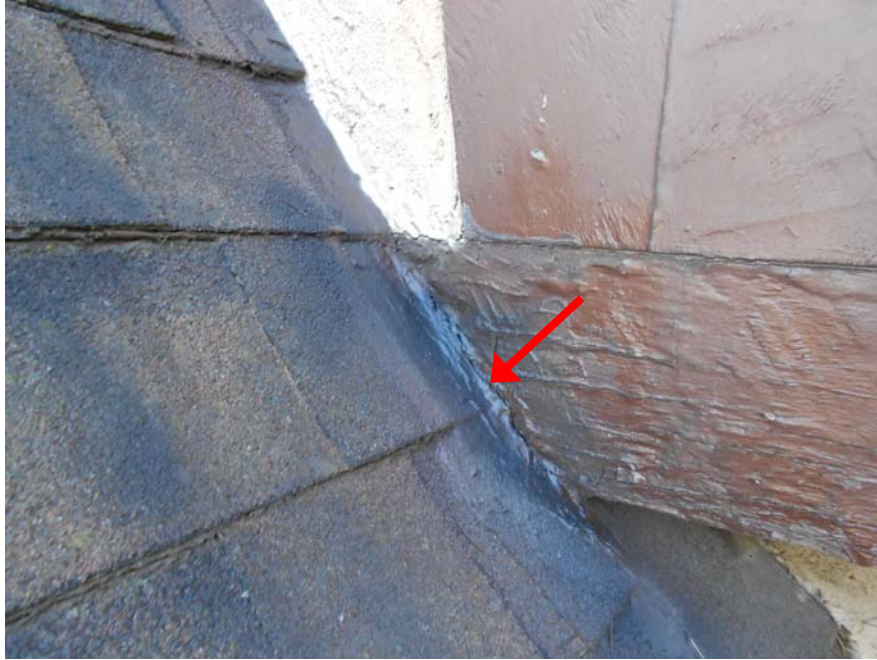
- This appears to be a recent repair where the front entryway meets the main house.

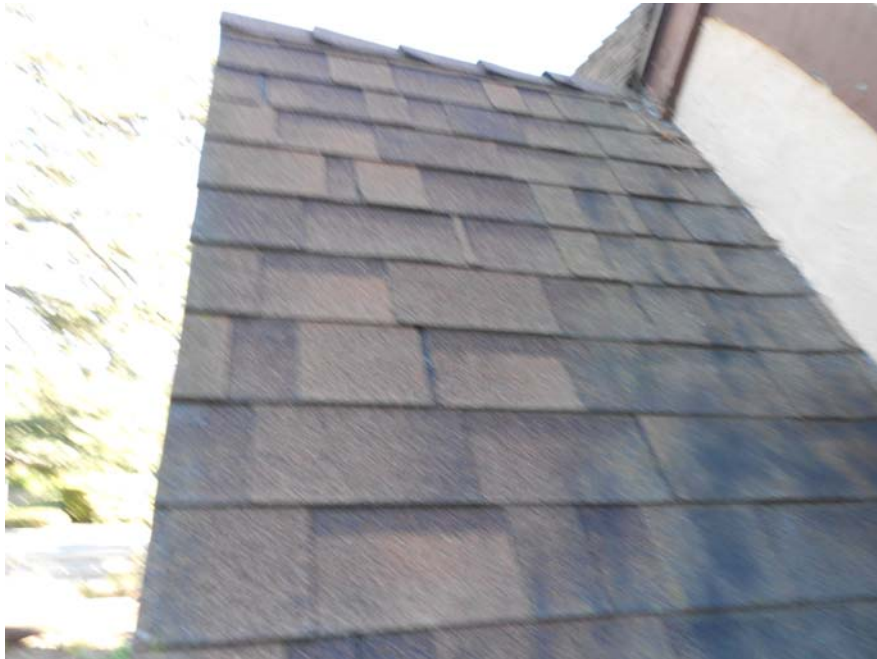
- This photo shows newer shingles on the left and older shingles on the right. It's not known why this approach was executed.

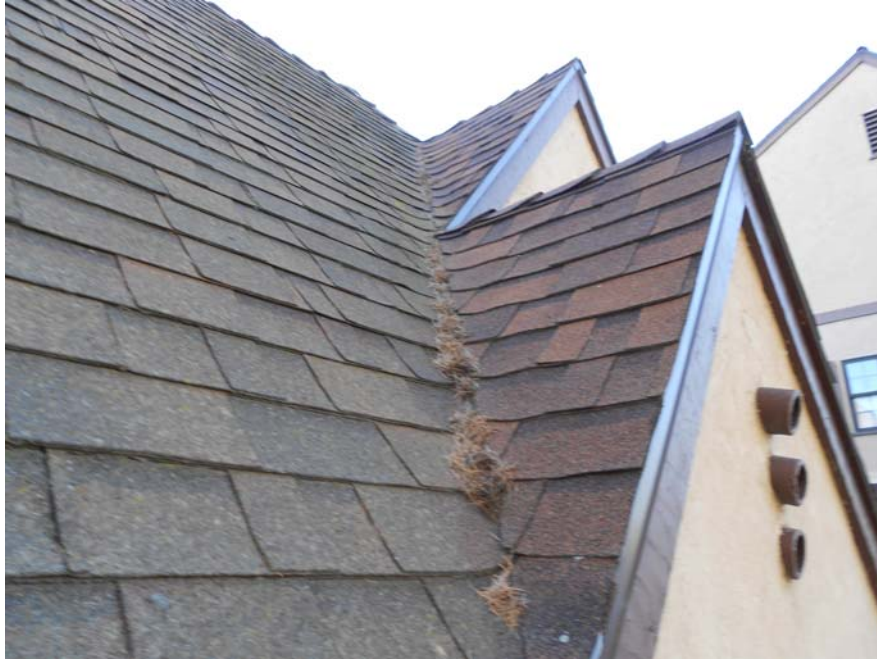
- This photo shows older shingles on the left (main house) and newer shingles on the right over the entryway.

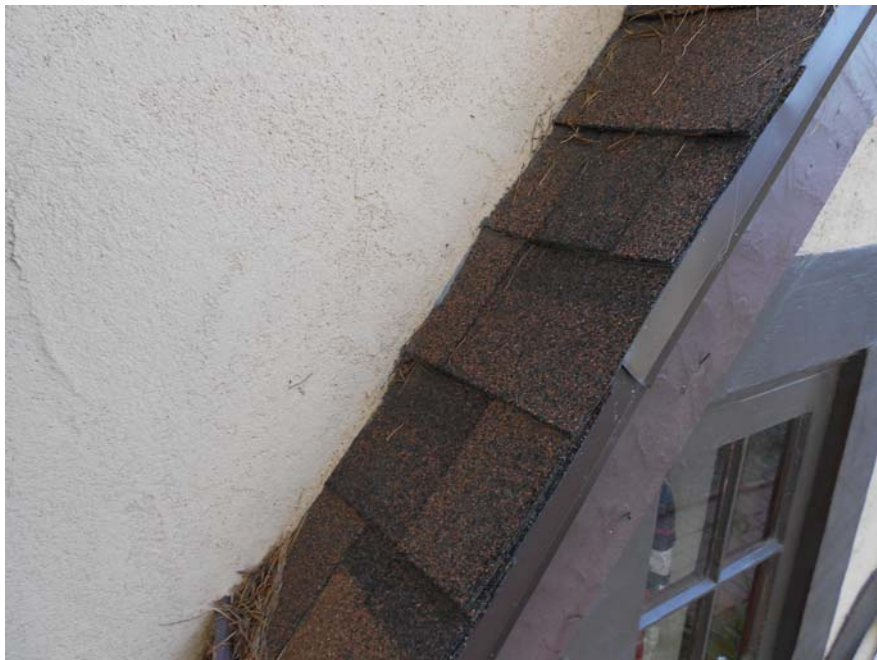
- These appear to be newer shingles and should have step flashing at the roof to wall connection. I was not able to determine that step flashing was used. The roof to wall connection appears to be sealed with mastic.

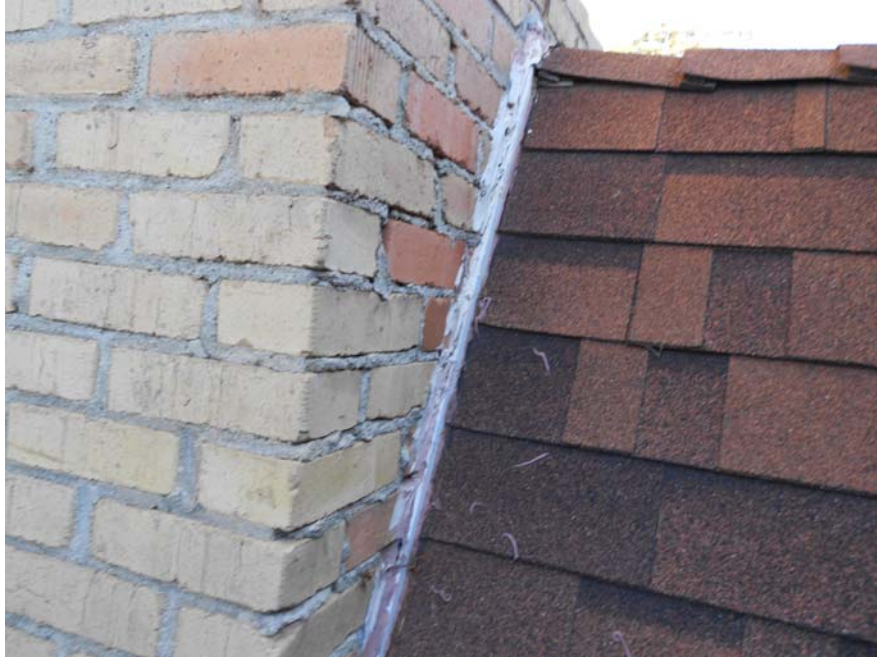
- This photo shows the back side of the chimney. There is no step flashing or counterflashing. The shingles appear to be sealed to edge metal using mastic. The seal between the edge metal and the bricks appears to have holes.

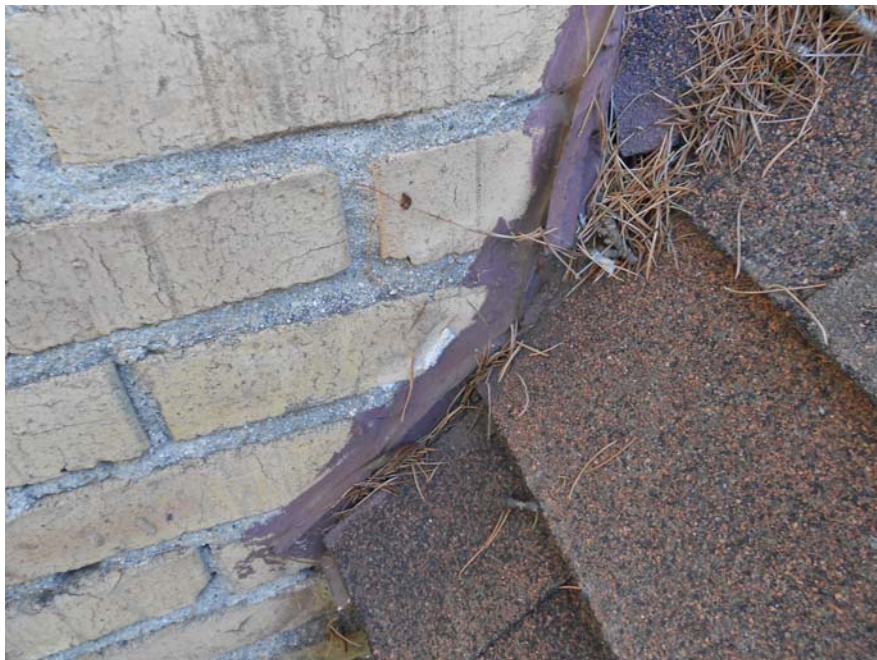
- This photo shows the sides of the chimney. Once again, there is no step flashing or counterflashing.

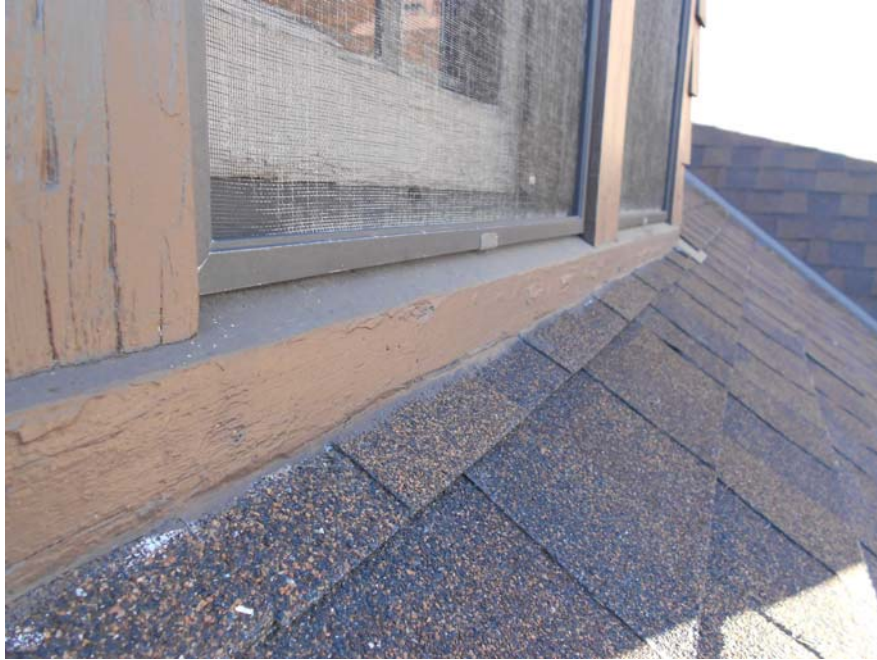
- This is the window in a roof dormer facing east. There does not appear to be a metal flashing below the windowsill.

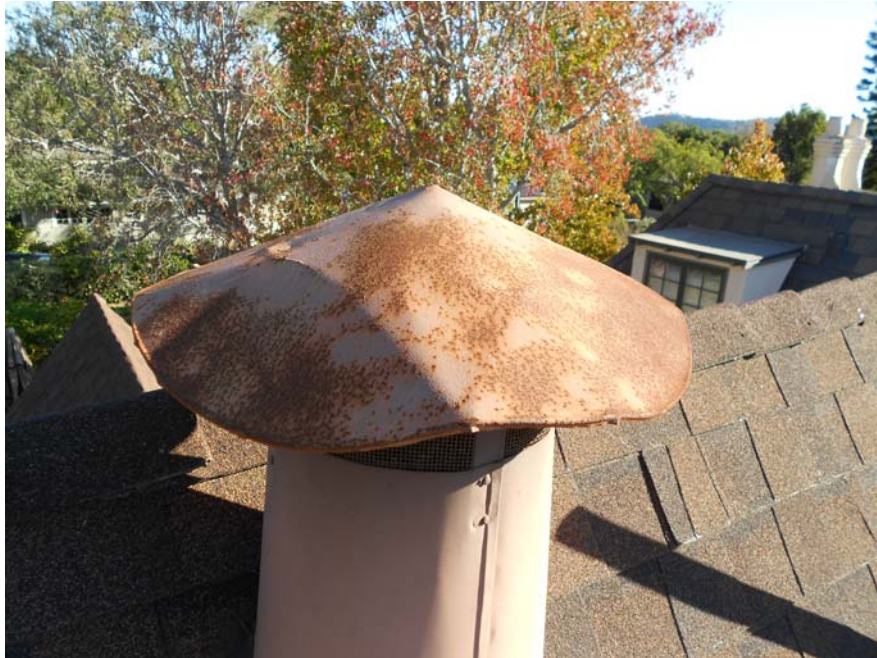
- The china hat on this vent appears to be badly rusted.

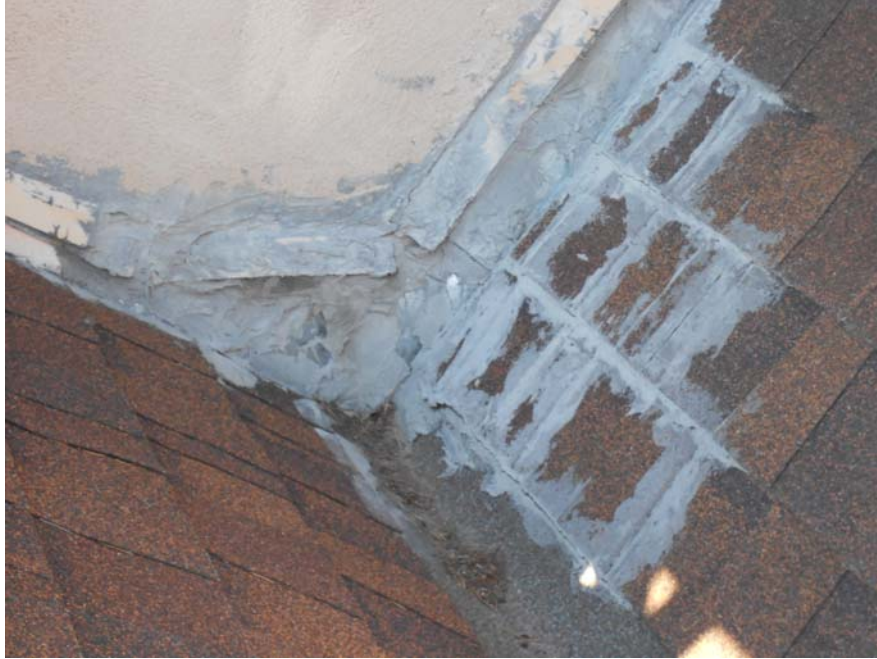
- There is a large cricket on the back side of the house adjacent to the new addition. The cricket appears to have been recently repaired. Safeguard Roofing suspects that this cricket may still be problematic. This type of a repair using mastic is usually temporary.

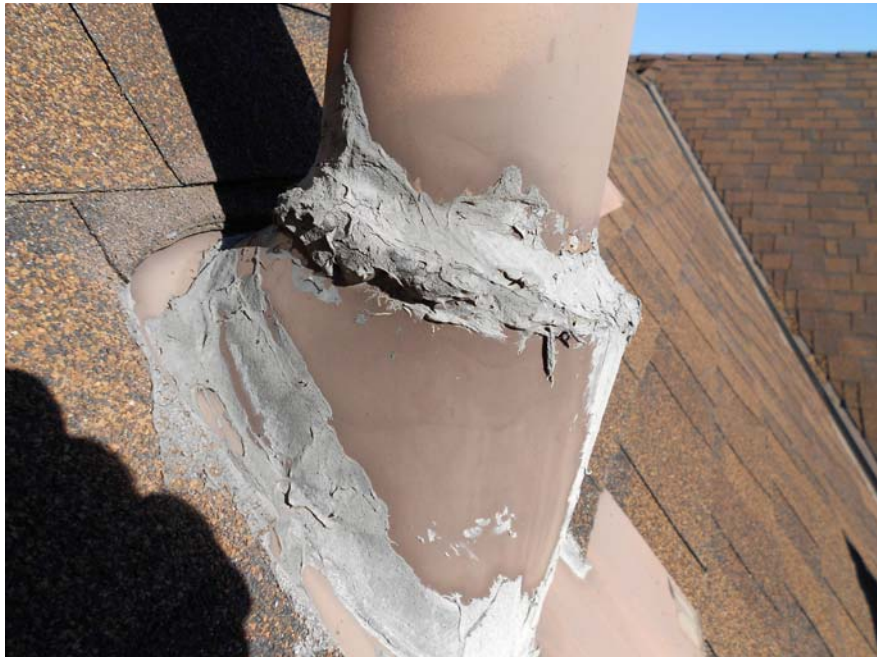
- This photo shows a vent pipe adjacent to the cricket. The seal on this vent pipe appears to be cracking.

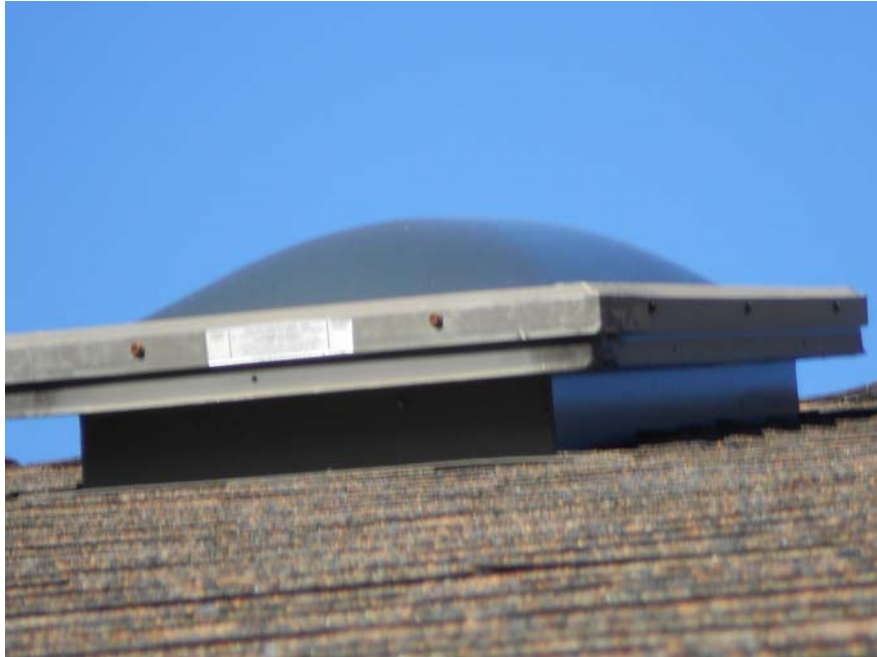
- A skylight has been installed on the second story of the new addition. The skylight is a self-flashing skylight and is meant to be hot-mopped into a flat roof. The skylight is the incorrect style for a sloped shingle roof. A curb-mounted skylight would be the proper skylight to be used for this installation.
