# Confidential Inspection Report

PROPERTY LOCATED AT:  
3101 Calle Mariposa  
Santa Barbara, California

INSPECTED ON:  
Tuesday, November 29, 2016

Inspector, George Blair  
Checkpoint Inspection Service

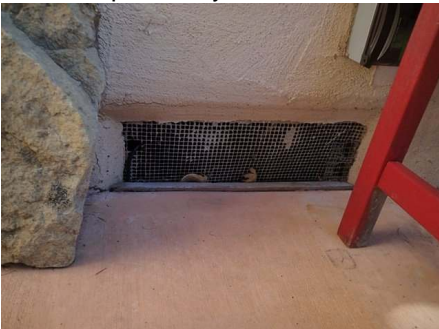
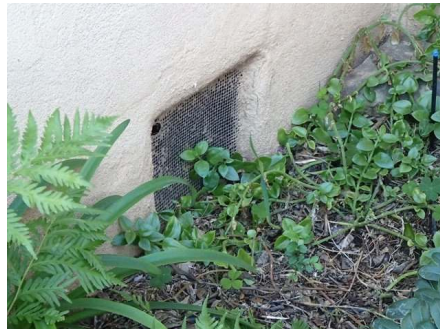
**ER 24:** - The soil level or walkways are even with or above the foundation vent screens and moisture intrusion will remain a possibility.

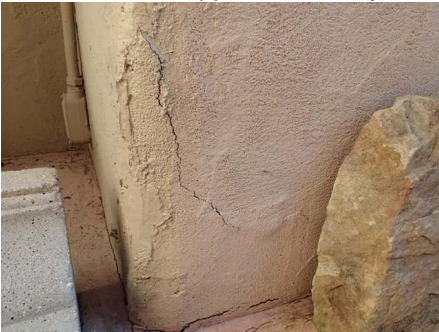
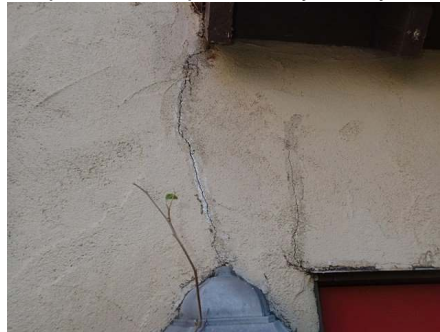
**ER 27:** - There are stress fractures in the stucco walls that result from movement, and are quite common. Most people don't realize that structures move but they do, and sometimes more or less continuously. Therefore, stress fractures can reappear after they've been repaired, and particularly if they've not been professionally repaired.

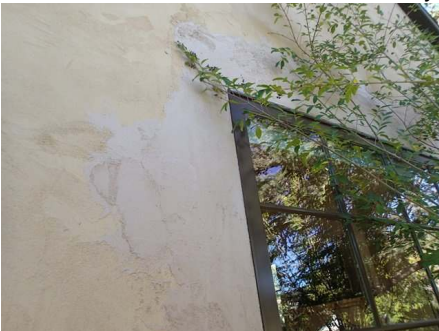
**ER 28:** - Patches were visible that you should ask about or have otherwise identified.

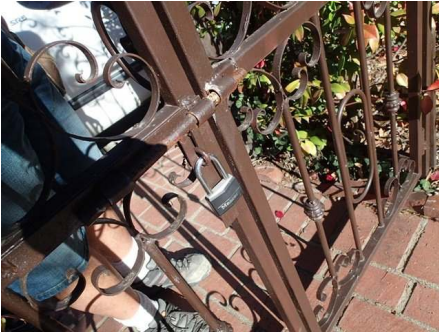
**ER** 35: - Locked gates were not tested.

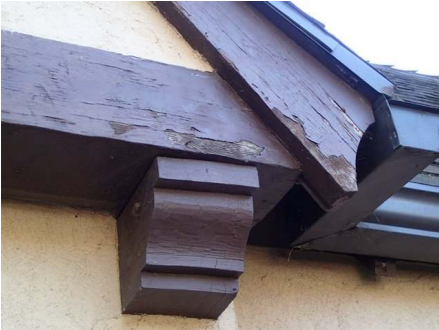
**NS** 36: - Peeling paint was visible that should be evaluated for service to protect the surfaces below.

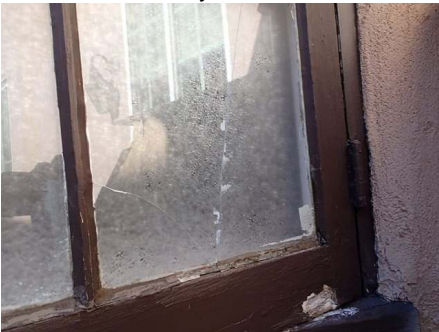
**NS** 40: - There are broken window panes which should be repaired. We may not identify all the damaged windows and recommend you have a window specialist evaluate.

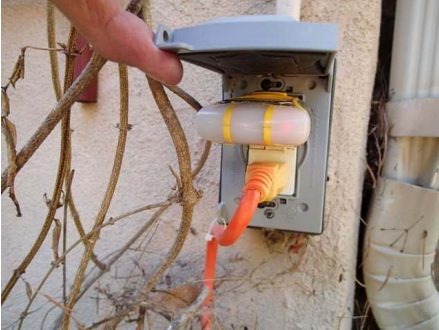
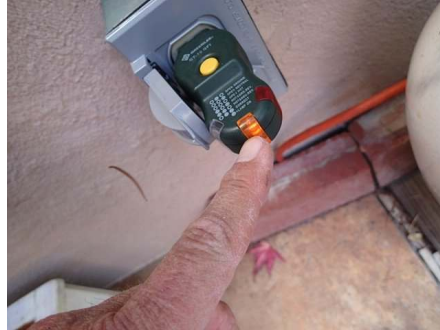
**ER UG** 45: - An outlet had a bad ground. We recommend the further review, advice and services of an electrician.

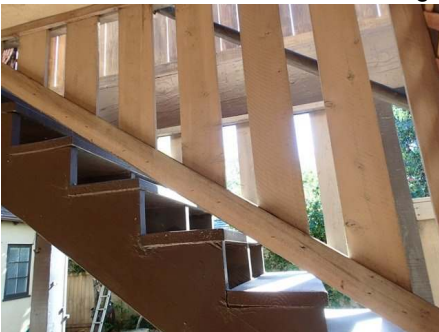
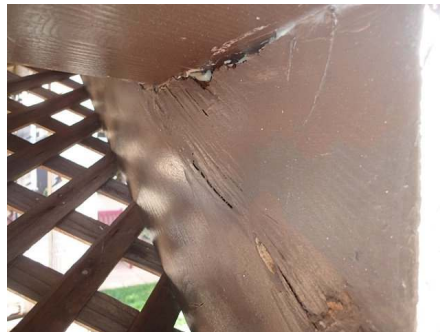
NS ER 54: - The stairs are damaged.

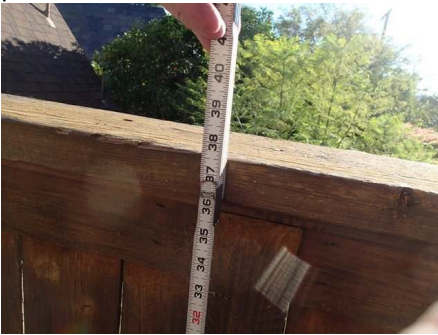
**ER** **UG** 57: - The guardrail does not conform to current safety standards. Common safety standards require them to be a minimum of forty-two inches high when the standing surface is thirty inches or more above grade. Also, guardrail pickets should be no more than four inches apart for child safety.

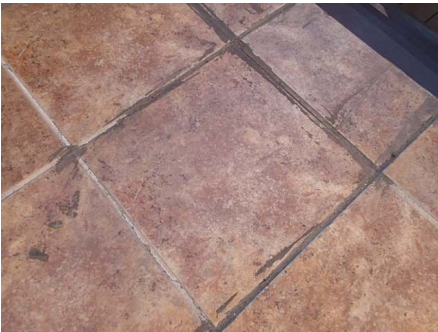
**NS** **ER** 58: - Patches were visible.

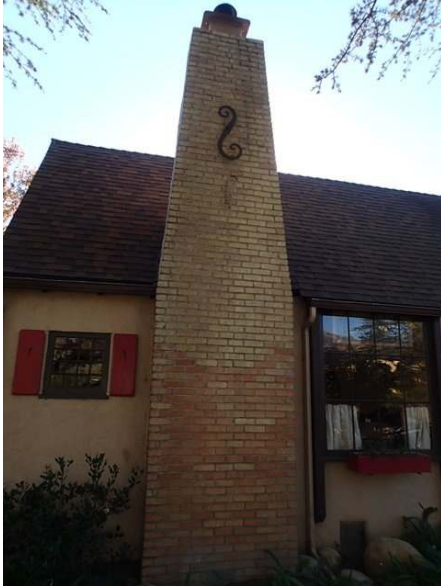
**ER 63:** - This chimney appears to have been altered.

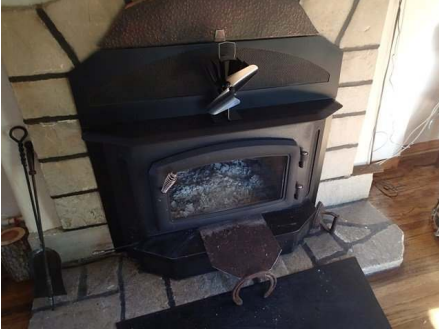
**ER 69:** - The fireplace and chimney should be evaluated. An insert has been added that prevents inspection without dismantling the system. In light of the potential fire hazard and the lack of visibility, we recommend the further review, advice and services of a chimney fireplace specialist.

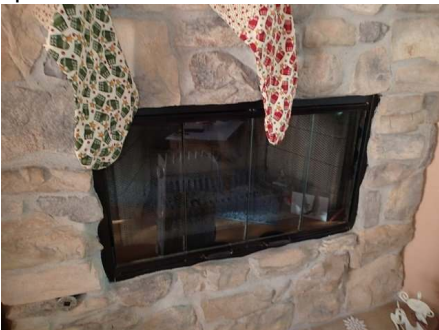
**ER 72:** - The chimney may not be original, or has been rebuilt. However, this should be confirmed by obtaining the permit, which would confirm that the installation included approved components and that the work was performed by specialists.

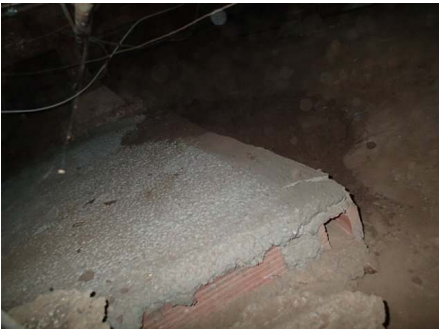
**ER 94:** - Alterations were noted in the crawlspace below the home. A brick and concrete structure was not identified.

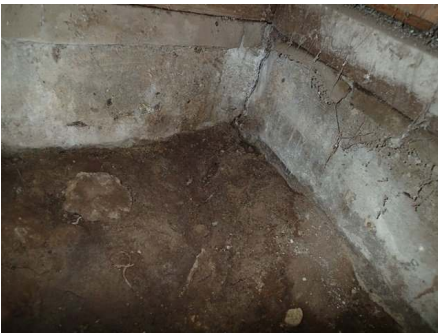
**ER 99:** - There are cracks in the foundation walls. Vertical cracks that are less than 1/4" and show no offsets or settlement are not uncommon and rarely indicate significant movement, but we are not specialists and you should consult with a foundation contractor or geotechnical specialist.

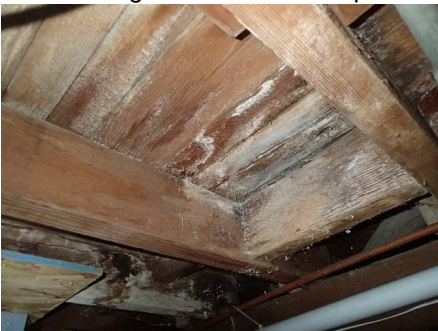
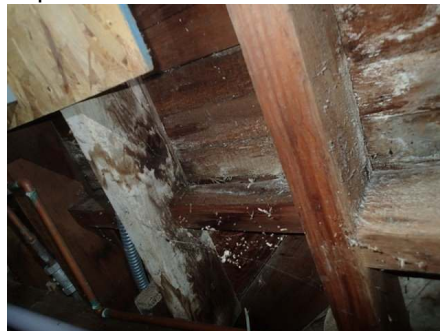
**ER 100:** - There are stains or moisture damage on the wooden components that confirm current or prior moisture.

The termite inspector should be consulted regarding stains or damage to the intermediate floor framing. Mold testing is outside the scope of this inspection.

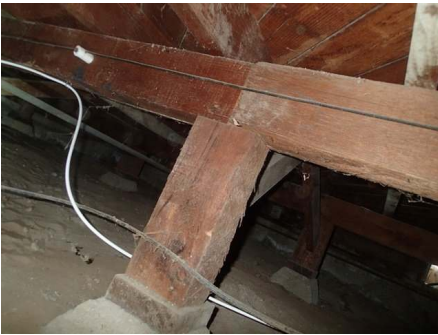
**ER 101:** - The posts and piers do not have positive connections, such as T-straps or Teco clips. These are required by current codes, but may not have been when this structure was built, and you may wish to have a specialist comment.

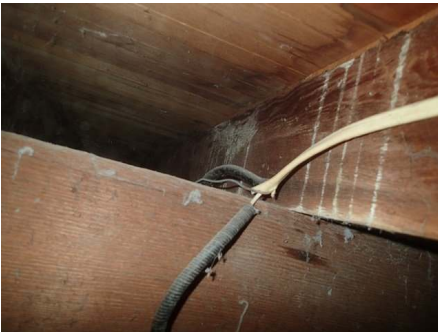
**NS 105:** - Improper wiring noted in the crawlspace. We recommend the further review, advice and services of an electrician

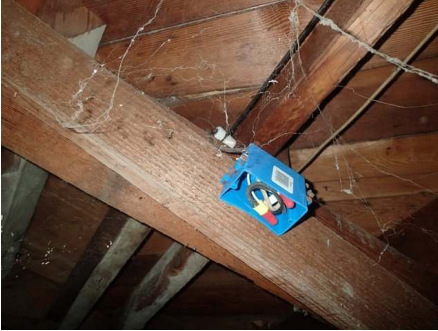
**NS** 106: - There are open electrical junction boxes within the crawlspace that should be sealed to contain any arcing or sparking would be contained within the box.

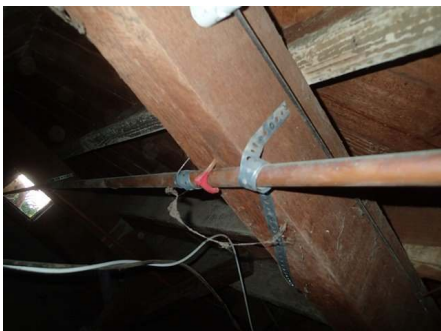
**NS** 128: - The copper pipes are incorrectly supported with galvanized hangers, which creates an electrolytic condition that could result in leaks.

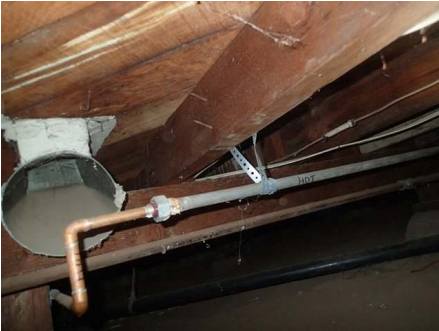
**ER 130:** - Some pipes were galvanized and you should evaluate further. We recommend the further review, advice and services of a plumbing contractor. Galvanized pipes do not last as long as copper or plastic pipes.

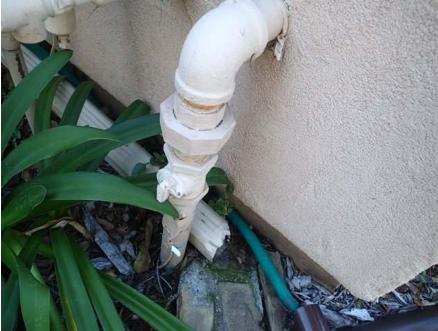
**ER UG** 134: - The gas main shut-off is located at the front of the residence . You should be aware that gas leaks are not uncommon, particularly underground ones, and that they can be difficult to detect without the use of sophisticated instruments, which is why natural gas is odorized in the manufacturing process. Therefore, we recommend that you request a recent gas bill from the sellers, so that you can establish a norm and thereby be alerted to any potential leak.

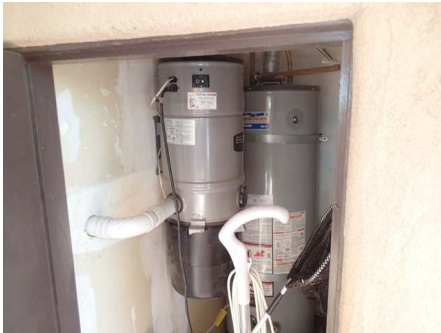
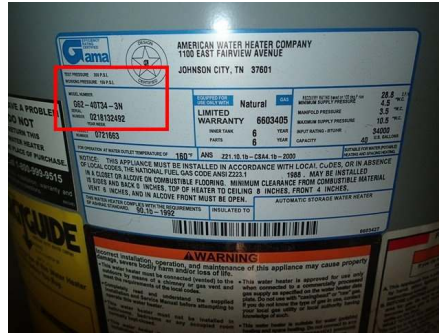
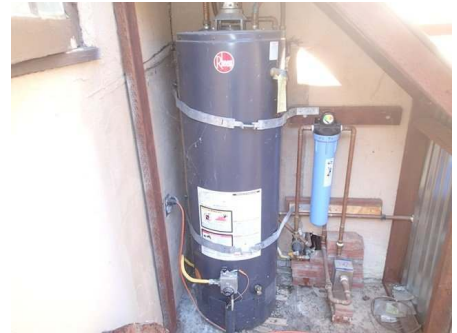
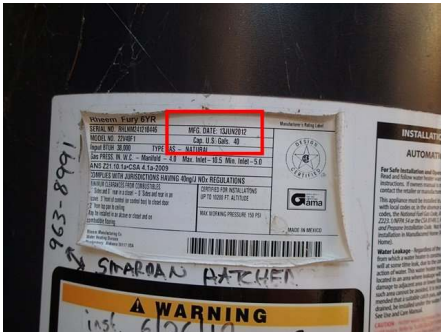
**140:** - Hot water is provided by a 14 and a two year old, 40 gallon water heaters that are located in an exterior cabinet or closet.

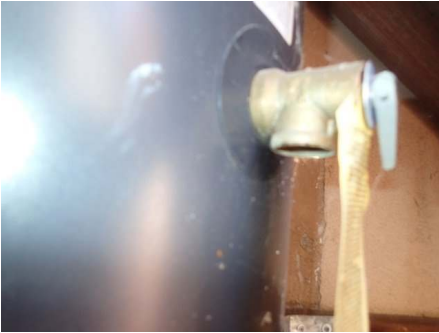
**NS 148:** - The pressure relief valve on the water heater does not have a discharge pipe. One should be installed that terminates at the exterior, approximately six inches above grade.

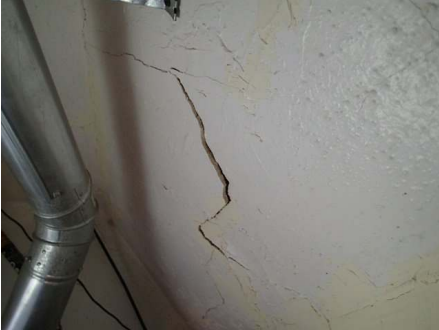
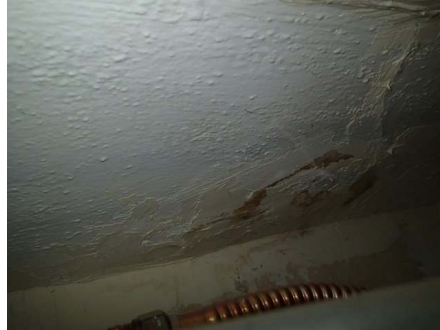
**ER 150:** - Unidentified stains and or damage were visible. Mold testing is outside the scope of this inspection.

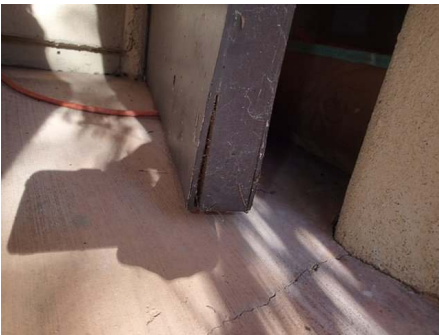
**NS 151:** - The door or doors need service.

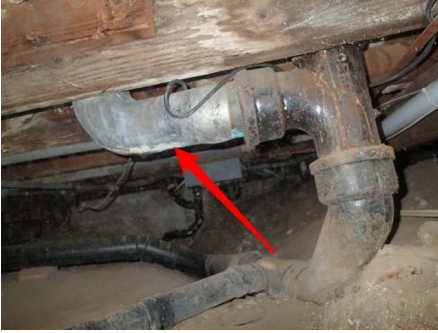
**156:** - The visible portions of the drainpipes include lead pipes, which would not be permitted by current standards.

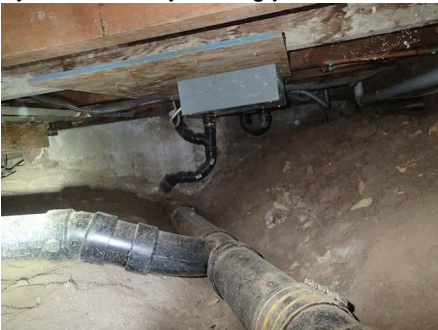
**ER 160:** - Alterations were noted. Check permits. We do not approve of alterations without approval and inspection by the authority having jurisdiction. Much of the system has been replaced with modern ABS pipes

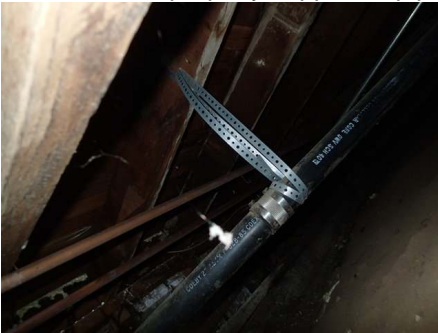
**ER 161:** - Improperly supported pipes. Metal straps, are substandard but not uncommon.

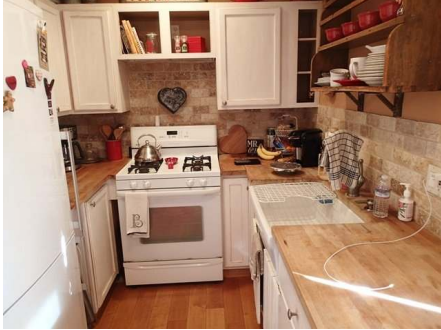
**174:** - The kitchen appears to be an addition, and we recommend that you obtain documentation for your records, which will confirm that the work was done by professionals. This is important because our inspection does not tacitly approve, endorse, or guarantee the integrity of any work that was done without a permit, and latent defects may exist.

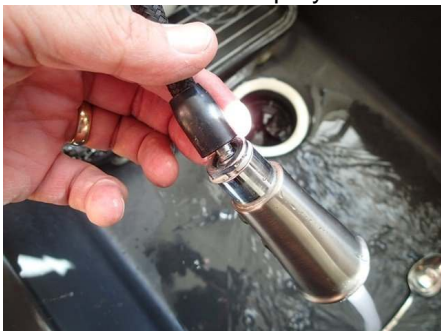
**NS** 192: - The hand sprayer on the faucet leaks, and should be serviced.

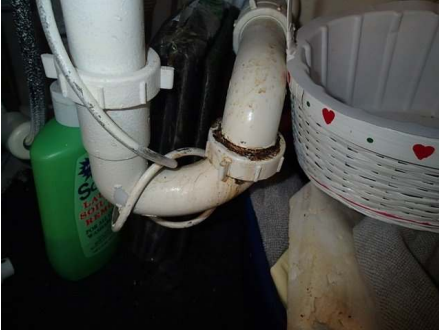
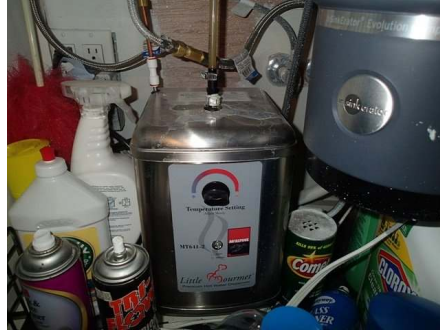
**ER 193:** - Stains confirm prior leaks.

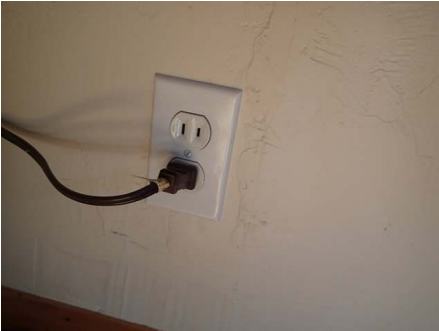
**ER UG** 224: - The ungrounded and obsolete outlets should be upgraded to include more modern and safer ones, which provide a pathway for the current to travel harmlessly to ground.

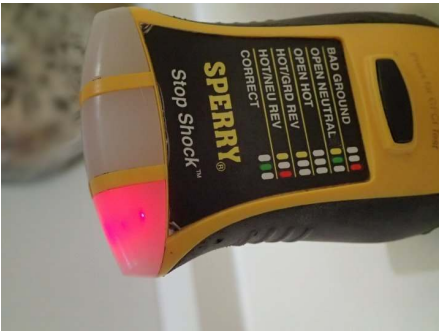
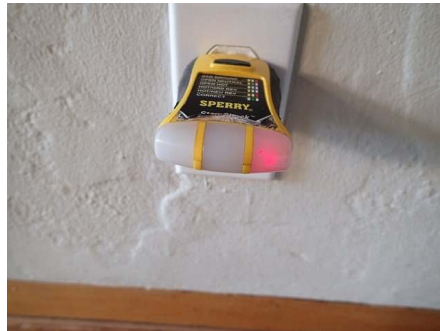
**ER UG** 225: - An outlet has a bad ground, and should be serviced. Several noted. We recommend the further review, advice and services of an electrician

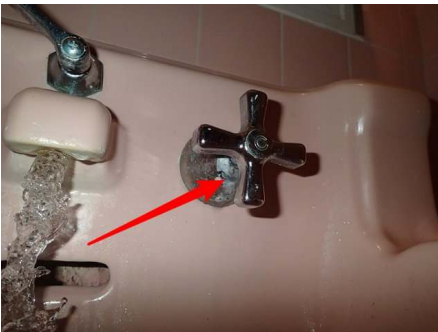
**NS** 240: - The sink faucet leaks around the stem while in use, and should be repaired.

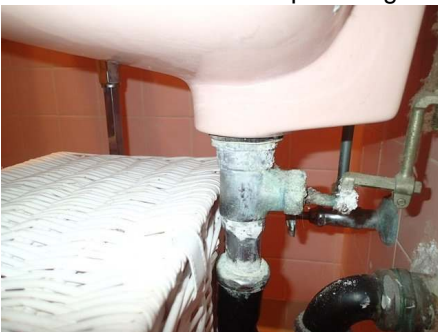
**ER** 241: - Corrosion was visible. This condition will not improve with time. We recommend the further review, advice and services of a plumbing contractor.

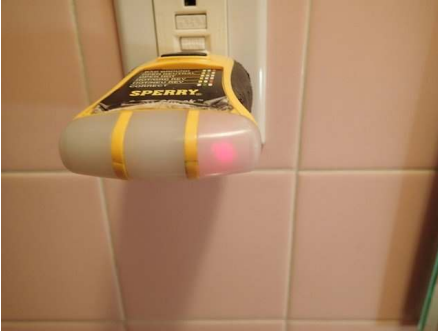
**UG** 245: - The sink outlet has an open-ground.

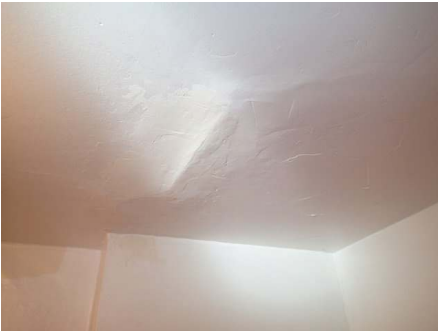
**ER** 246: - Patches were visible that you may want to identify.

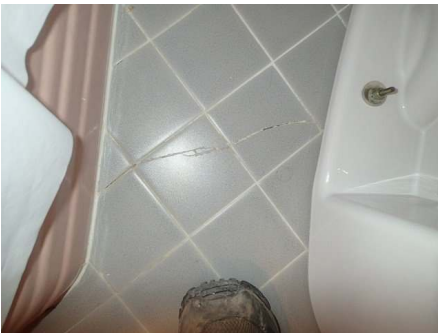
**ER** 247: - There are cracks in the tiles. We recommend the further review, advice and services of a flooring contractor.

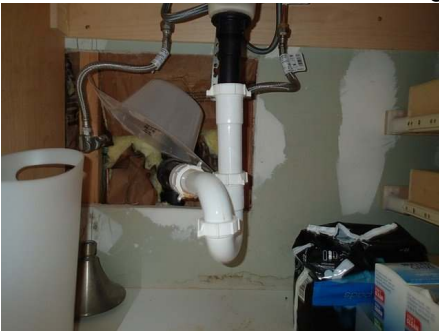
**ER** **252:** - Holes in the wall or ceiling visible in the cabinets.

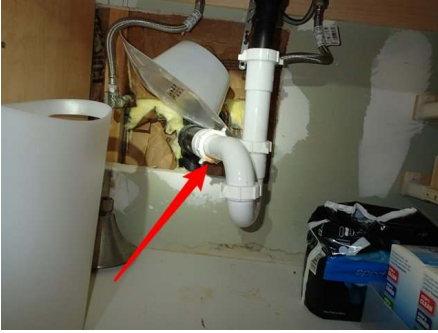
255: - Moisture stains confirm prior leaking.

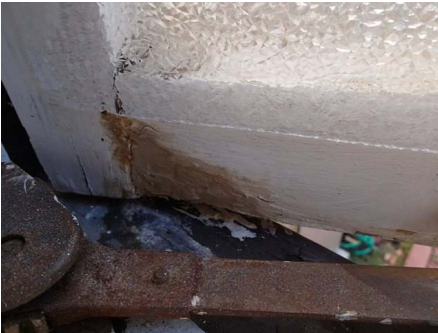
**ER** 259: - There are moisture stains around the window. Plastic glazing glued to the window.

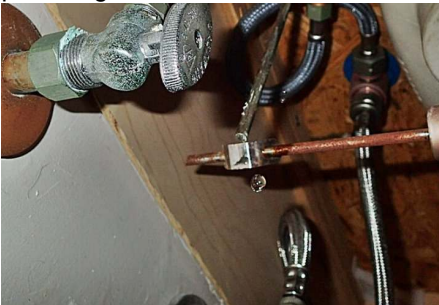
**NS** **ER** 265: - There is a leak below the sink that should be repaired. We recommend repairs by a qualified plumbing contractor.

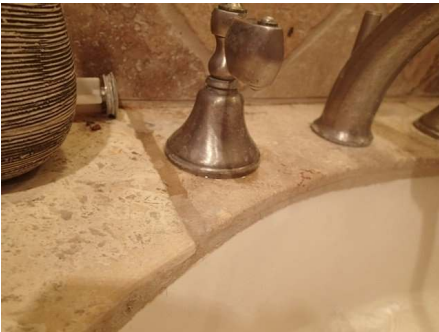
**NS** 267: - The sink faucet leaks around the stem while in use, and should be repaired.

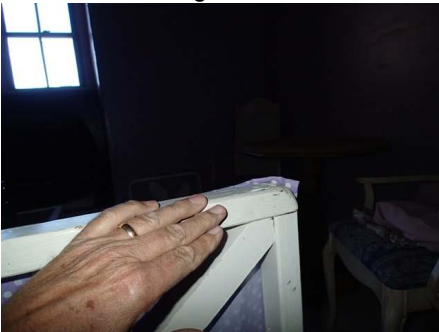
**NS** 283: - The guardrail is loose and should be secured for safety reasons.

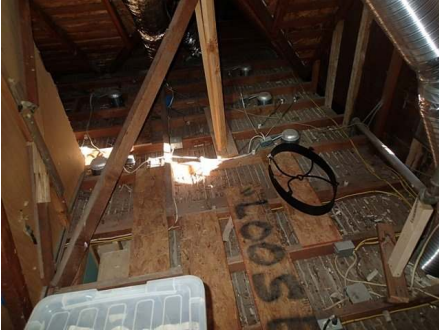
**UG** 284: - A suspect walk way or cat walk has loose boards could lead to falls and injuries. We recommend the further review, advice and services of a general contractor.

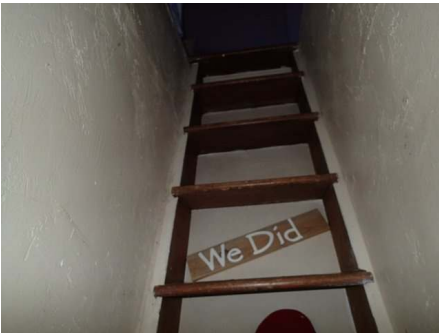
286: - The attic can be accessed through a location noted within the report. Hallway ladder.

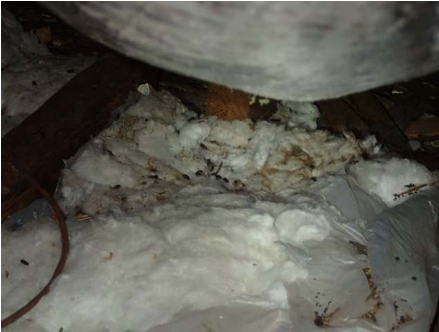
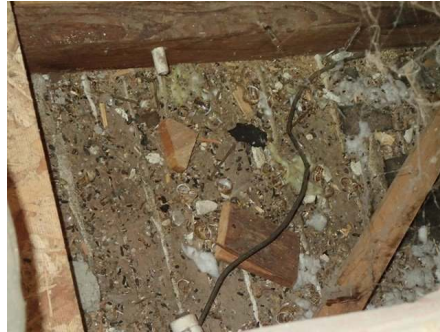
**NS ER 288:** - The attic has evidence of rodents within, which is a health hazard, and should be evaluated by an exterminator. Rodents can compromise not only the attic and its various components, such as ducts and insulation, but can eventually compromise the living space as well. Consequently, we disclaim any further responsibility for evaluating the attic and its components.

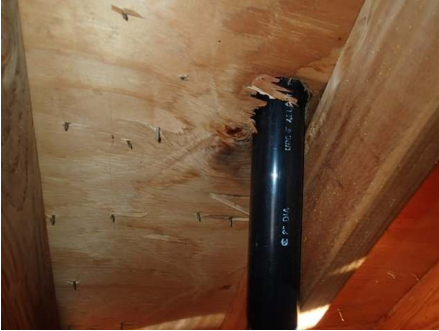
**ER 293:** - There is evidence that the roof has leaked but we are unable to determine if the leaks are active because it was not raining during the inspection.

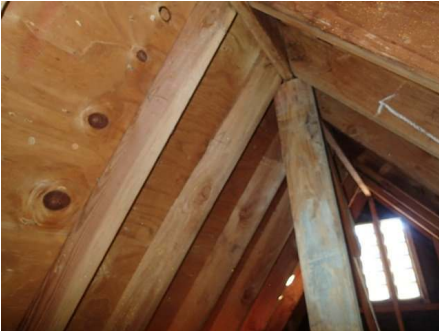
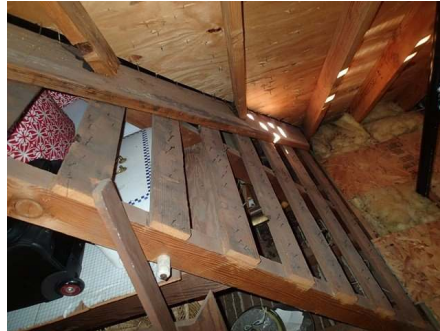
**ER 295:** - The framing has been altered and you should contact the owner or a qualified contractor for information about any alterations.

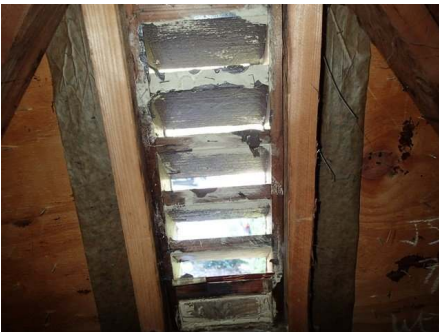
**NS 296:** - The ventilation port screens are damaged or missing which may allow rodents or other pests to enter and contaminate the area.

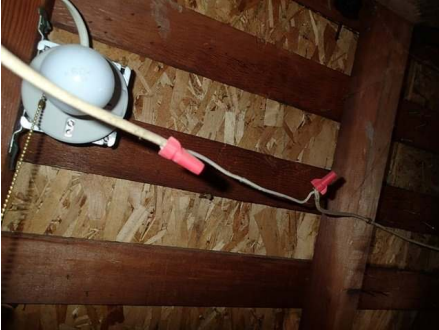
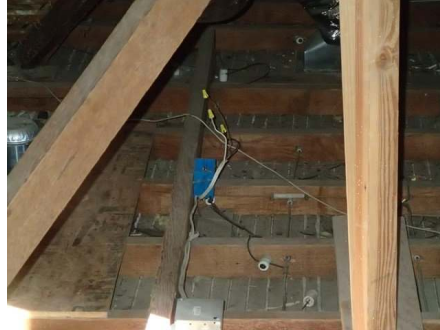
**NS** **ER** 297: - Improper wiring was visible.

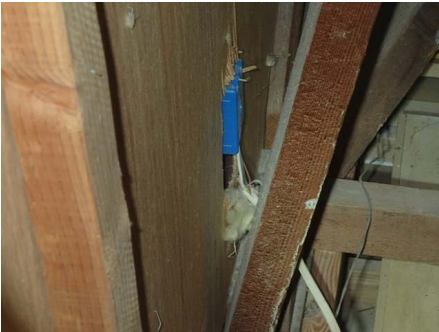
**NS** **ER** 299: - Electrical conduits were not professionally installed, and include detached electrical junction boxes, loose or unsecured vinyl conduit, or conduit without restraint clamps, et cetera, which should be serviced by a licensed electrician.

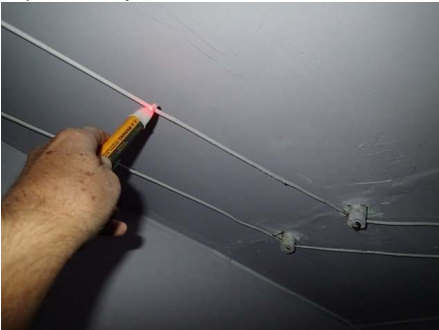
**ER** 300: - Obsolete and suspect knob and tube wiring is present, which should be inspected and certified as safe, or replaced by a licensed electrician.

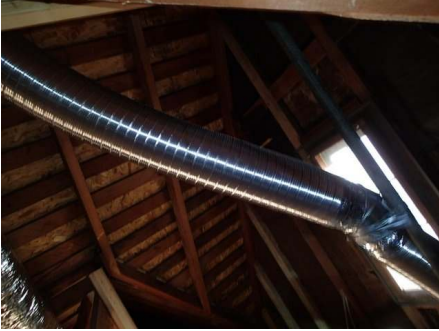
**ER 302:** - Suspect materials noted. The aluminum flexible duct is not be rated for kitchen exhaust installation. I recommend the further review, advice and services of a general contractor

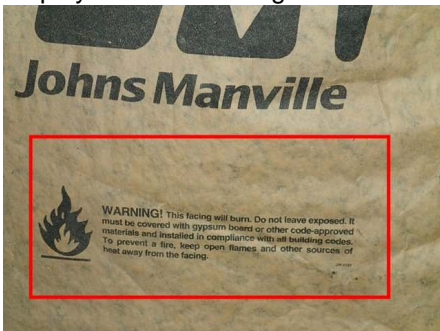
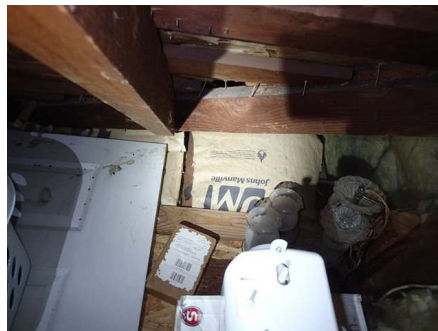
**ER 303:** - There were some areas that were not completely covered with insulation.

**UG 304:** - The exposed paper face on the insulation is improper. The paper can burn and caution should be employed when working in the attic.

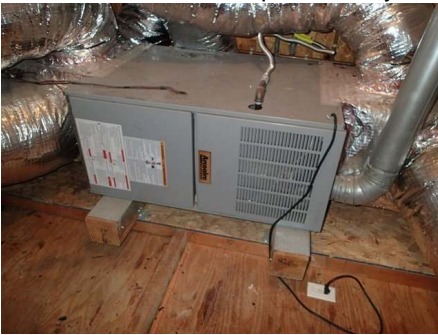
305: - Central heat is provided by a forced-air furnace that is located in the attic.

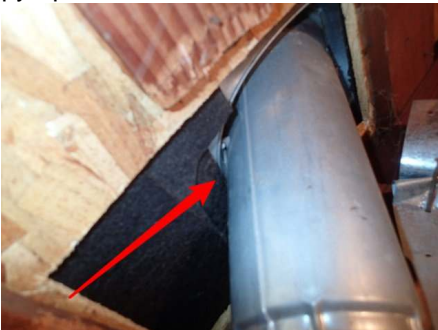
**NS** 308: - The double-walled vent pipe should be one inch away from combustibles, or it could create pyrophoric conditions and a fire-hazard, and should be serviced by an HVAC contractor.

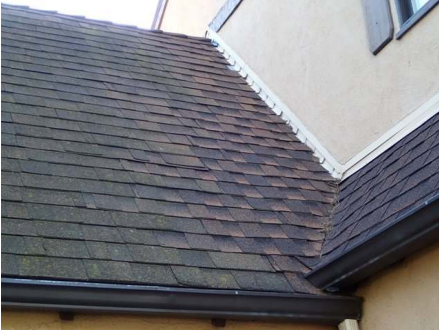
**ER** 322: - Patches were visible on the roof that you may want to have identified.

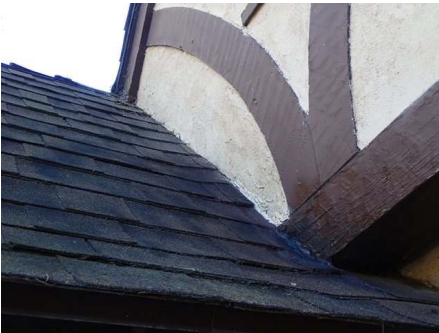
**ER** 324: - There is no visible wall flashing. We recommend the further review, advice and services of a roofing contractor.

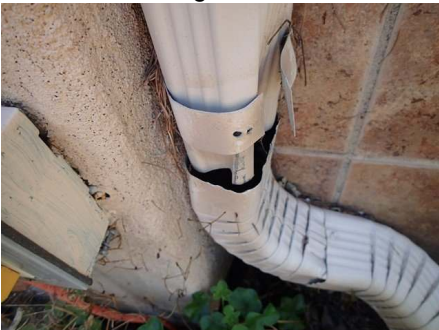
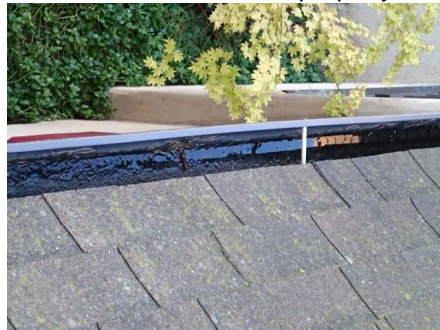
**NS** 325: - The gutters need to be cleaned and serviced to drain properly.

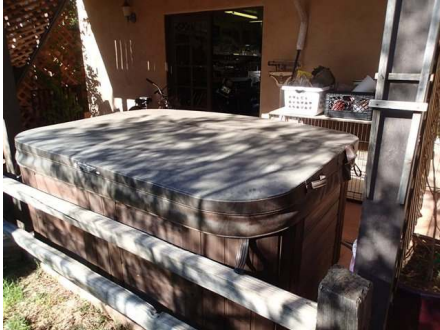
**ER 326:** - We did not evaluate the spa system as part of our inspection service. Therefore, you should have a pool / spa contractor evaluate before the close of escrow, and you should be aware of local ordinances governing pool and spa safety. Electric and gas connections for spas require permits and inspections from the authority having local jurisdiction. We do not approve of additions or alterations without permits and inspections. Spa Inspections are available for an additional fee.
